PRIVATE
MANAGED
FOREST LAND
COUNCIL

**Report on Audit
of
Private Managed Forest Properties
2006**

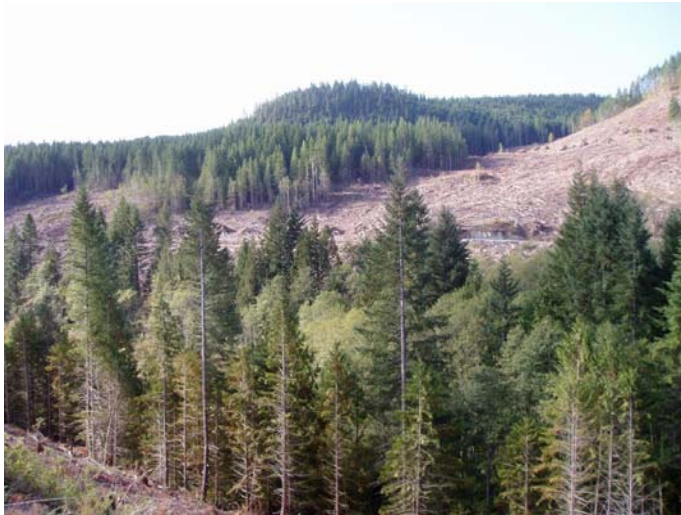
Streamside tree retention in foreground, Quinsam River area.

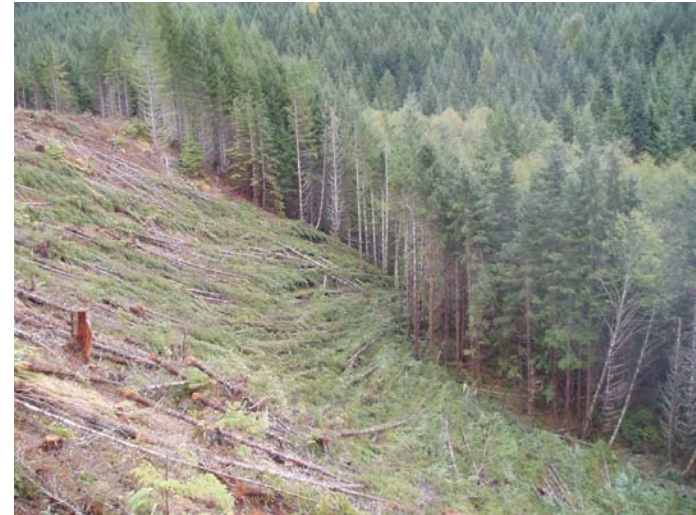
Streamside tree retention below felled timber.

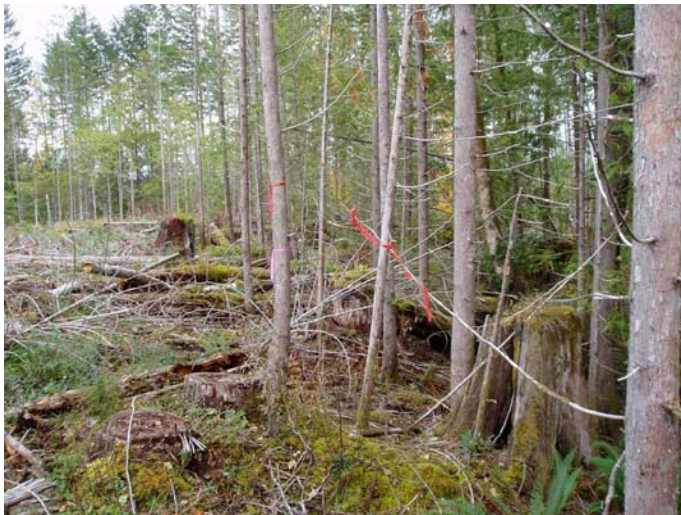
Streamside tree retention along a small stream.

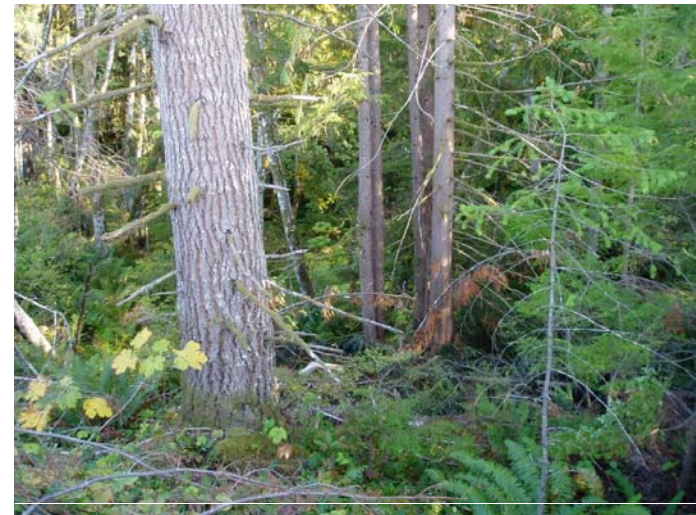
Streamside tree retention, Black Creek.

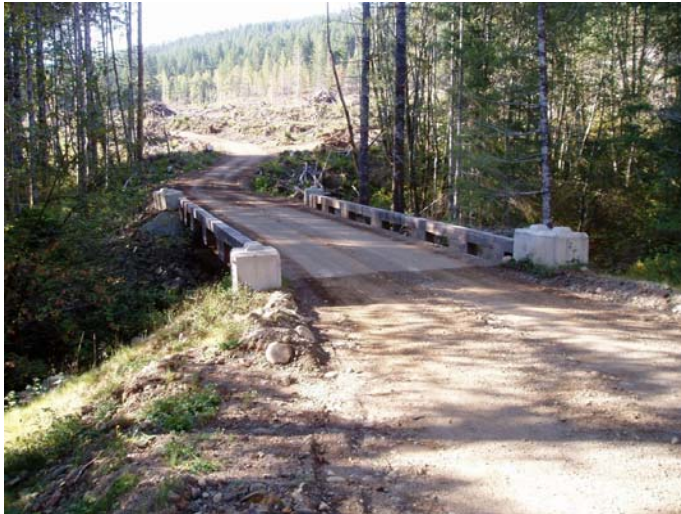
Permanent bridge and streamside tree retention, Tsable River area.

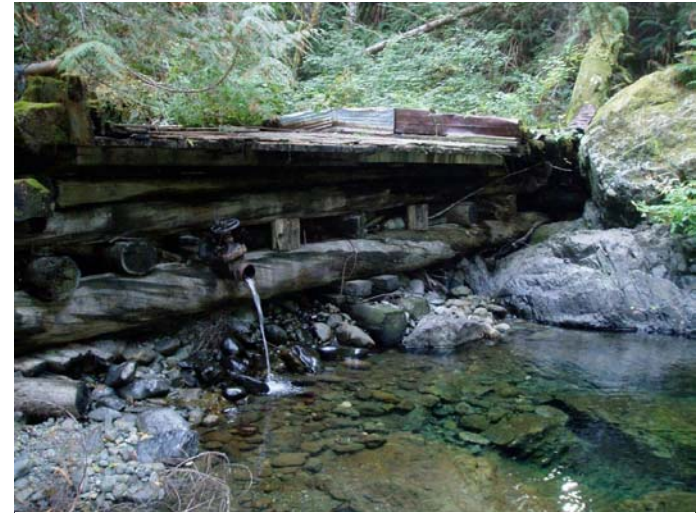
Old domestic water catchment at McGee Creek near Sooke.

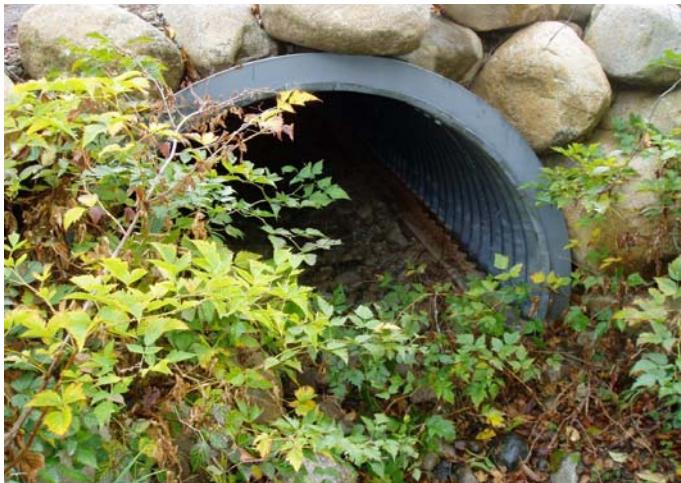
Open bottomed plate arch culvert.

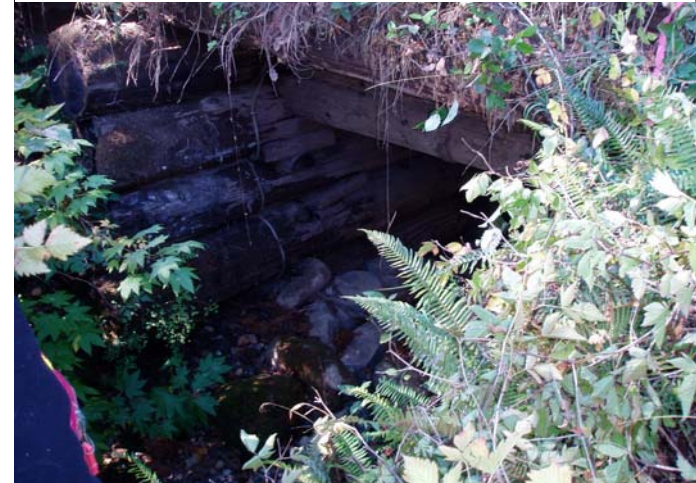
Structurally sound old wooden culvert.

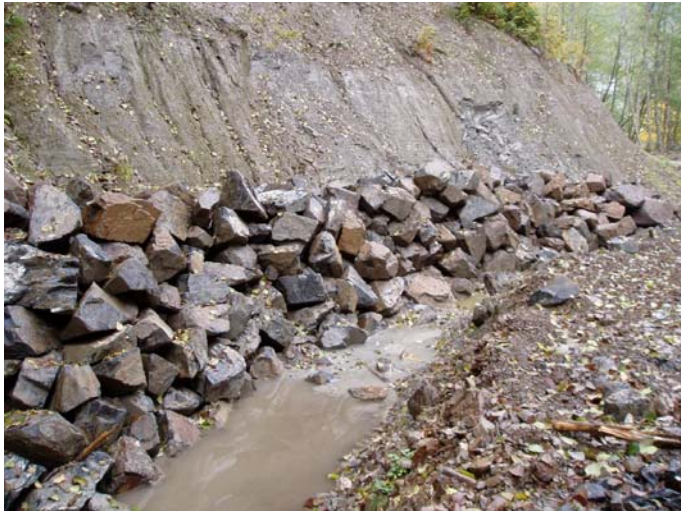
Rock used to stabilize cutbank at newly constructed road.

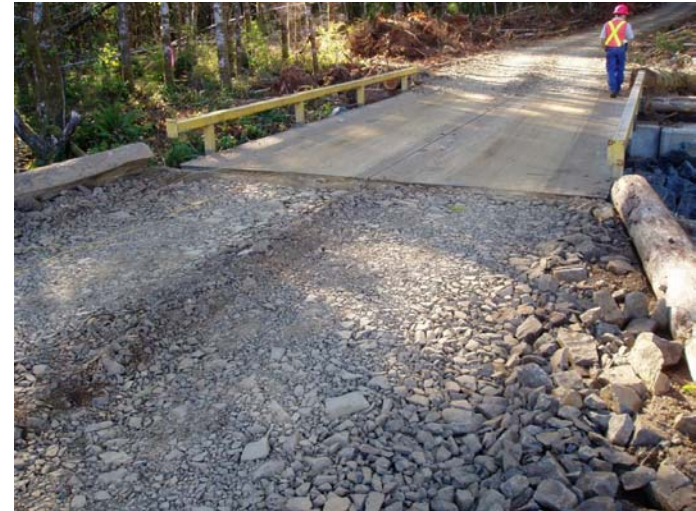
Non-erodible road surfacing reduces sediment transport to stream.

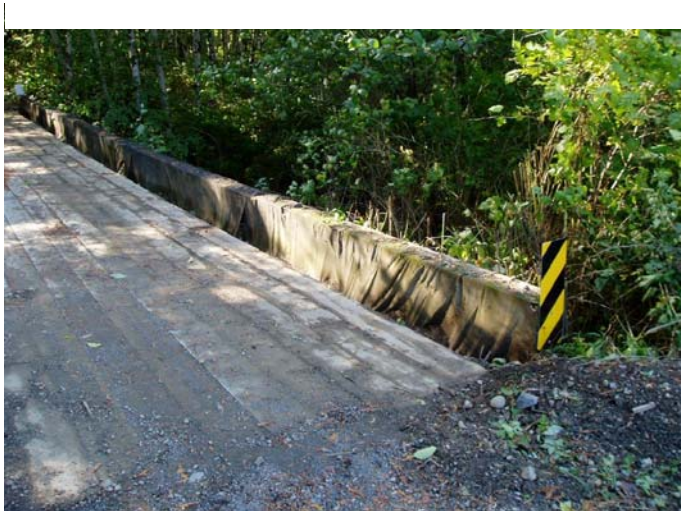
Filter cloth reduces sediment entering stream at bridge.

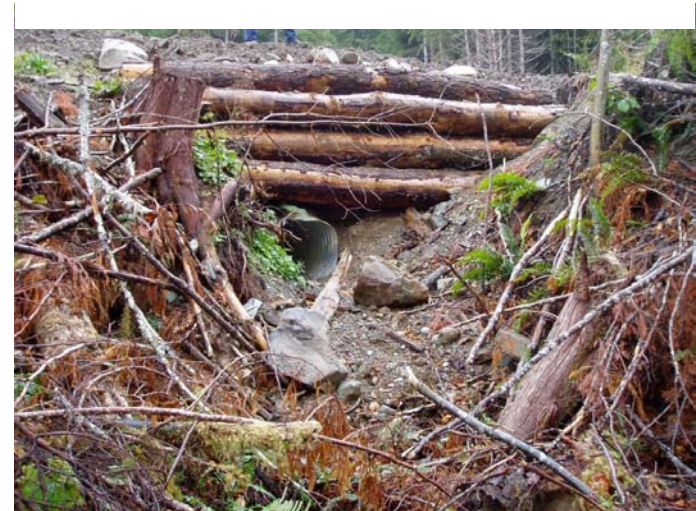
Logs do not fully retain road fill above a small stream.
