PRIVATE  
MANAGED  
FOREST LAND  
COUNCIL

**Report on Road Audit  
of  
Private Managed Forest Properties  
2009**

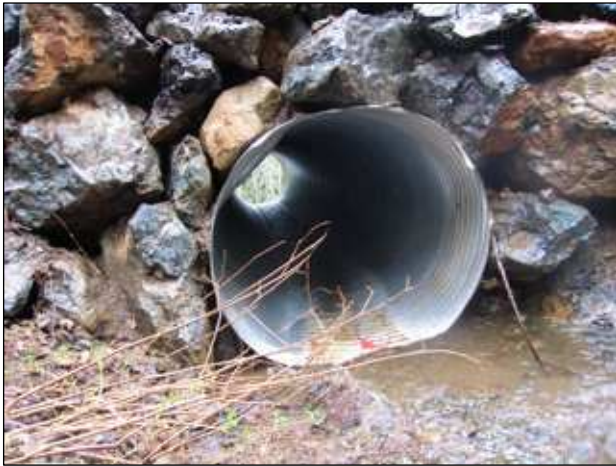
1. Culvert inlet armoured with placed shot rock.

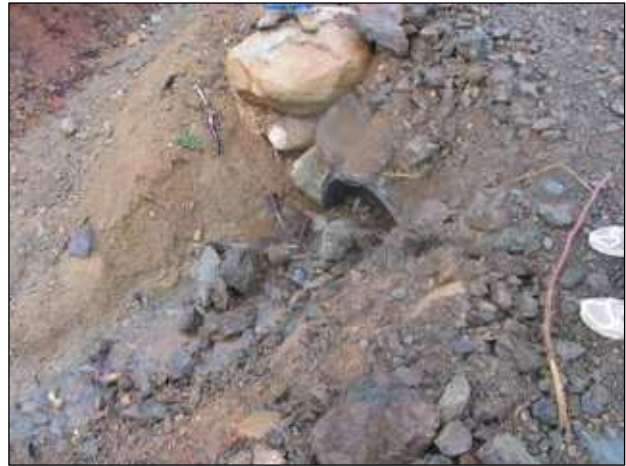
2. Culvert too short and outlet partially plugged.

- ensure culverts are long enough to clear the road surface and minimize ravelling and/or adversely affecting the inlet / outlet function
- ensure culvert installations are effective for depth, cover and gradient and the outlet is armoured if necessary to minimize erosion potential

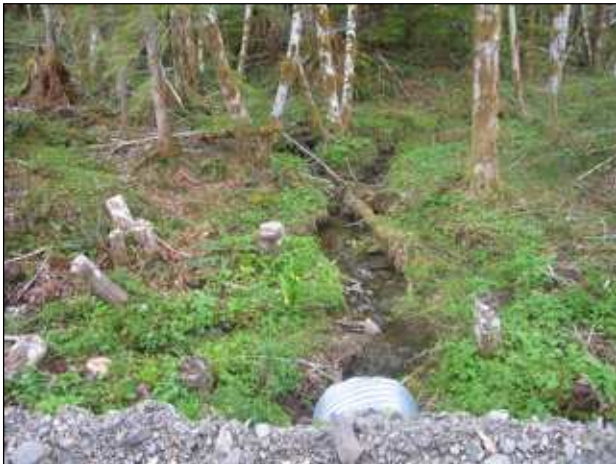
3. Natural drainage pattern maintained.

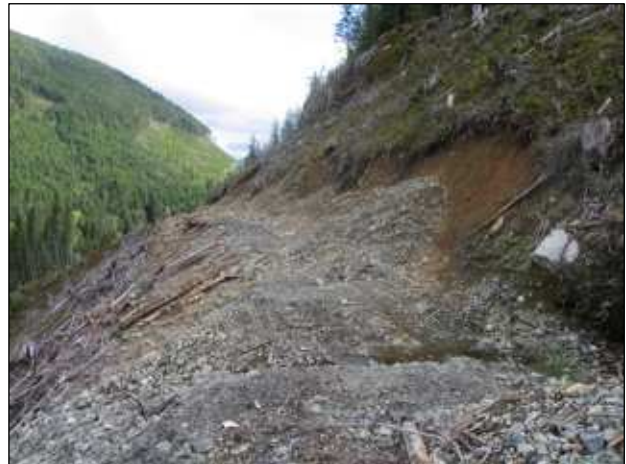
4. Effective pullback and cross-ditch on deactivated road.

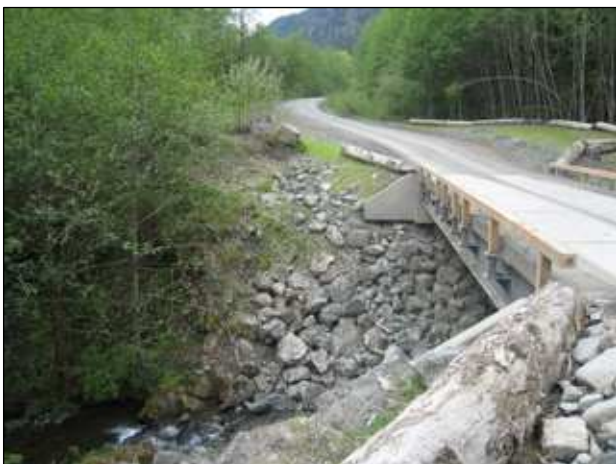
5. New steel girder, concrete deck bridge replaced an old log stringer, gravel deck bridge on this old, heavily used main line. Note use of rip-rap and grass seeding.

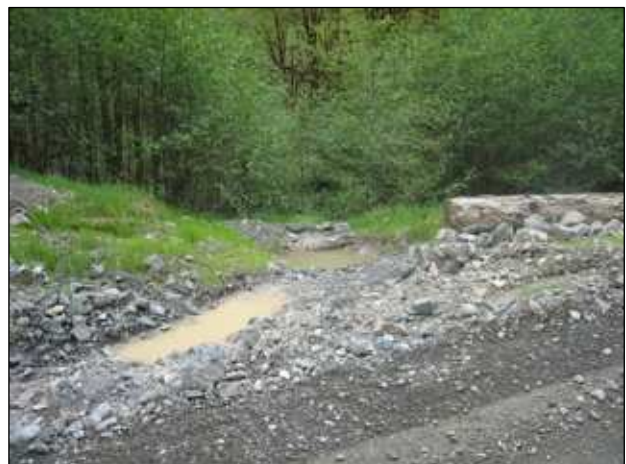
6. Settling basins in ditchline can be cleaned out periodically to help to reduce risk of sediment delivery.

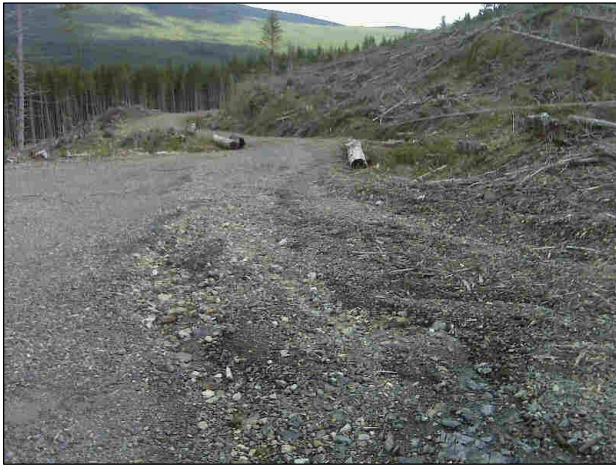
7. Looking down-grade. Note rill erosion caused by ditch water discharging onto running surface of road.

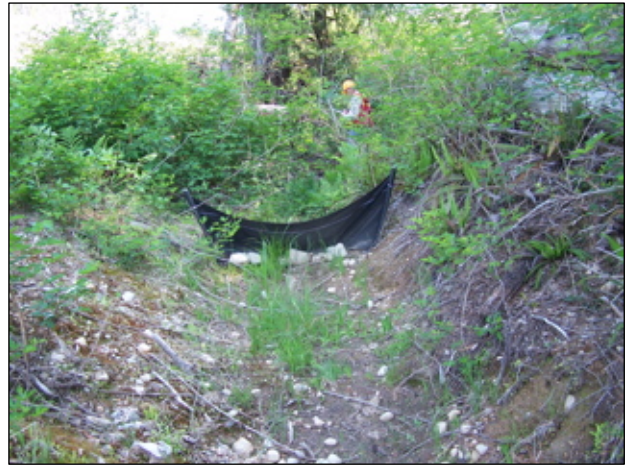
8. Silt fence installed on ditch before stream to help minimize sediment deposition.

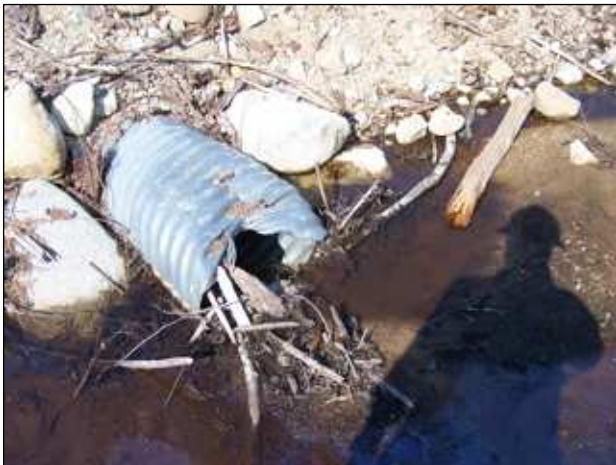
9. Culvert inlet partially blocked by sediment build-up. Digging a sediment trap would help here.

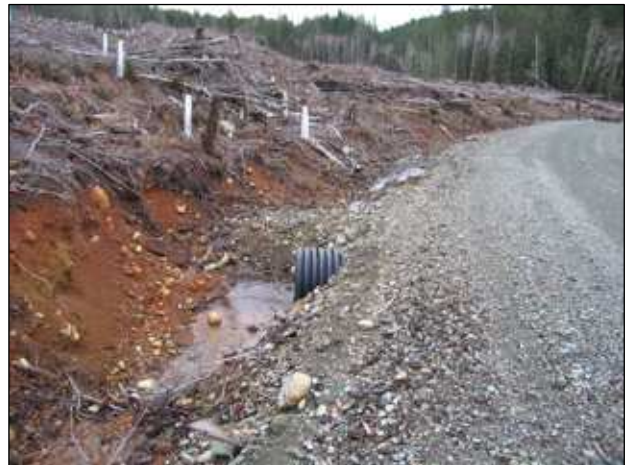
10. Culvert ditch block, and ditch cleared after harvest to prevent road fill encroaching.

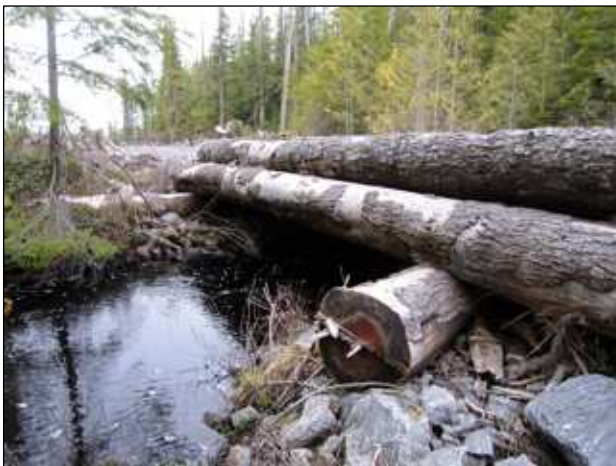
11. Large wood box culvert; sill logs well back to leave clear channel clear channel.

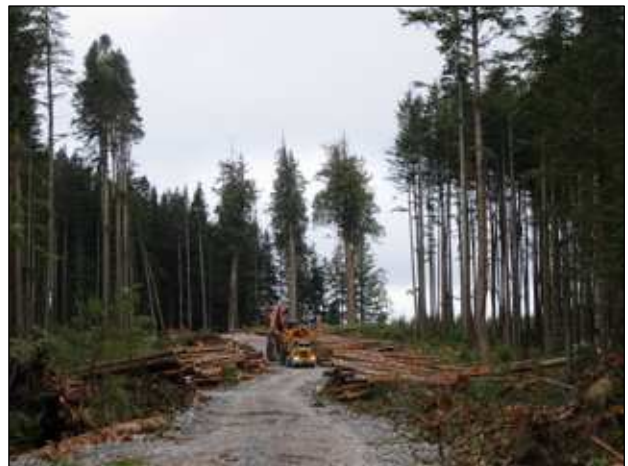
12. Logging on very new, well ballasted road.

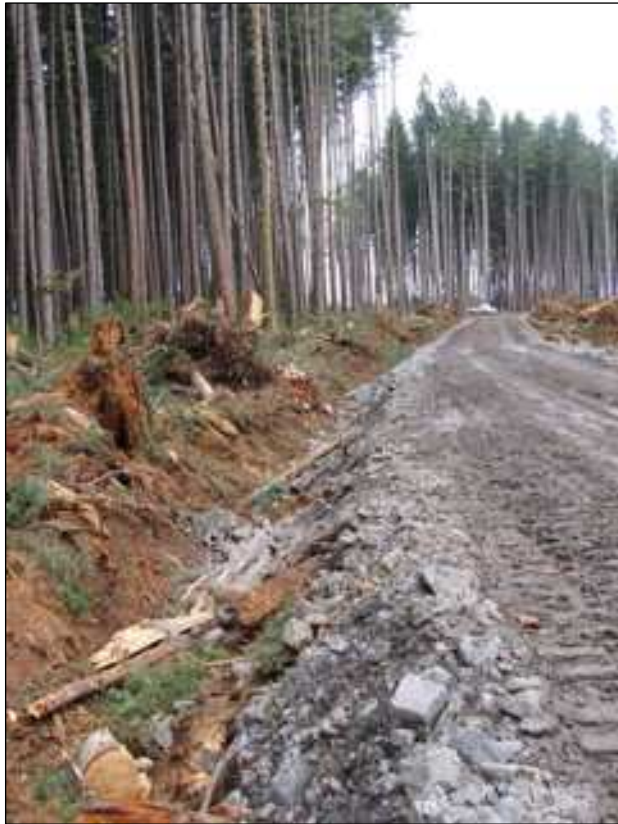
13. New road, ditch cleared of debris after right-of-way logs loaded out.

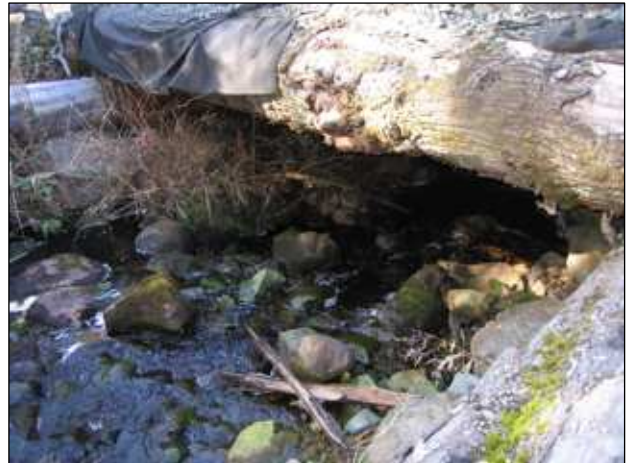
14. Wood culvert with sill logs well back leaving channel undisturbed. Note use of geo-fabric used to contain fines.

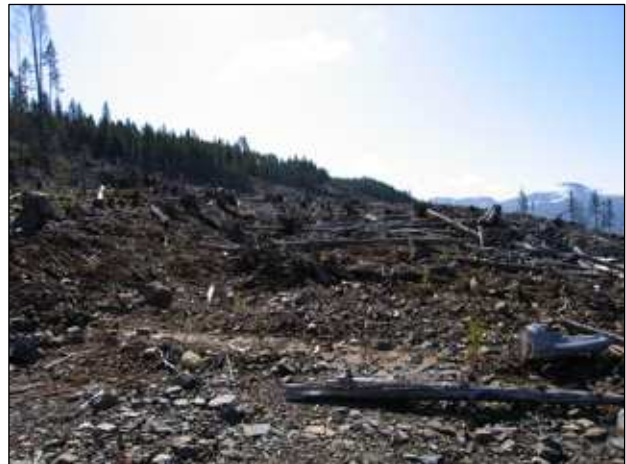
15. Example of road reclaimed and restocked after harvest completed.

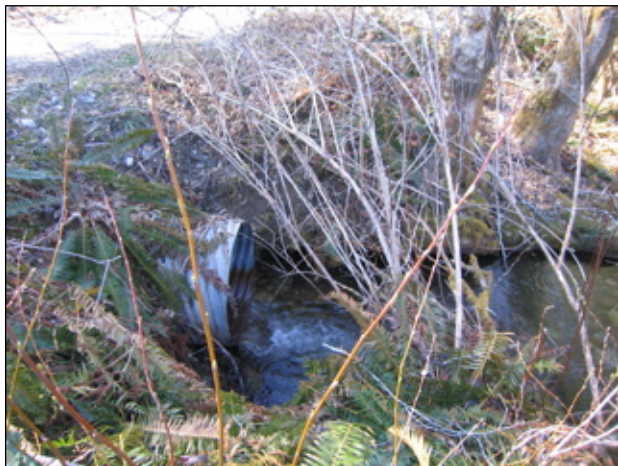
“perched” culvert where fish passage is impaired or a road is adjacent to a stream reach increasing the risk of sediment delivery, the owner is generally aware of and dealing with these issues.

16. Legacy road issue – perched culvert outlet on fish stream.

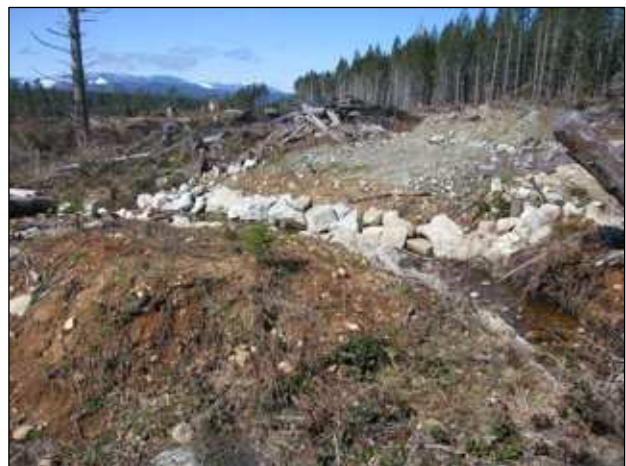
17. Culvert removed on deactivated road. Rip-rap remains in place to protect soil from erosion.
