CW500 Block Assessment Beech Creek

- TimberWest Forest Corp. -

Block Assessment of WF500 Beech Creek TimberWest Forest Corp.

July, 2007

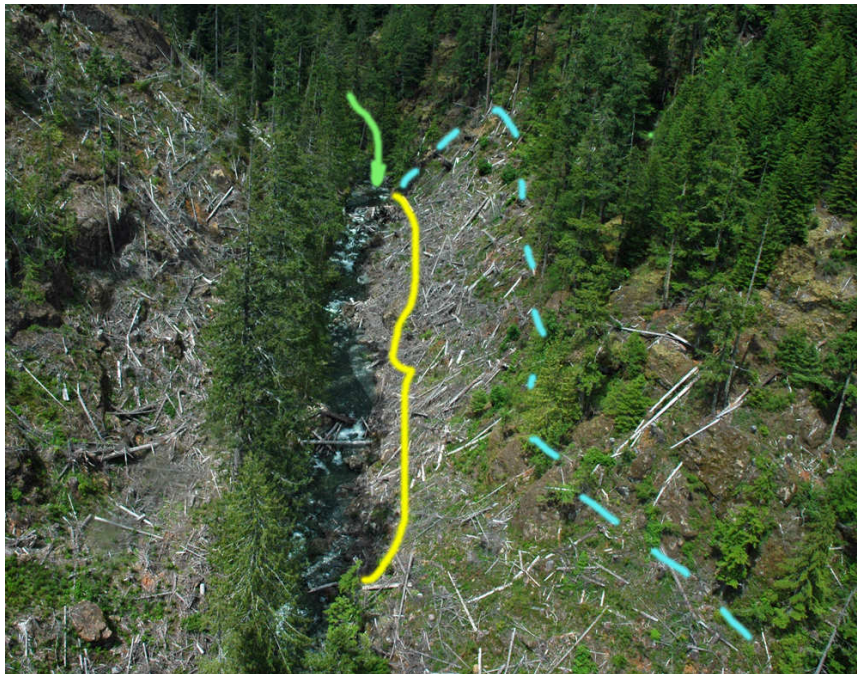
No trees were retained adjacent to the left bank (facing downstream) of Beech Creek within Block CW500 (Photo 1). TimberWest has conducted and documented a detailed stump inventory and the results of this survey indicate that pre-harvest conditions would have allowed for a sufficient number of trees to be retained within 10 m of the stream channel (Photo 2).

Photo 1 Aerial view of Block outlined with blue dotted line. The green arrow shows the direction of stream flow. The harvested left bank of Beech Creek is delineated with a yellow bracket.

No special remedial works are recommended. It is recommended, however, that TimberWest ensure that riparian trees grow back as quickly. The site has already been planted. The site should be inspected periodically as a priority to ensure that conifers reach free-to-grow status if this is not already planned.

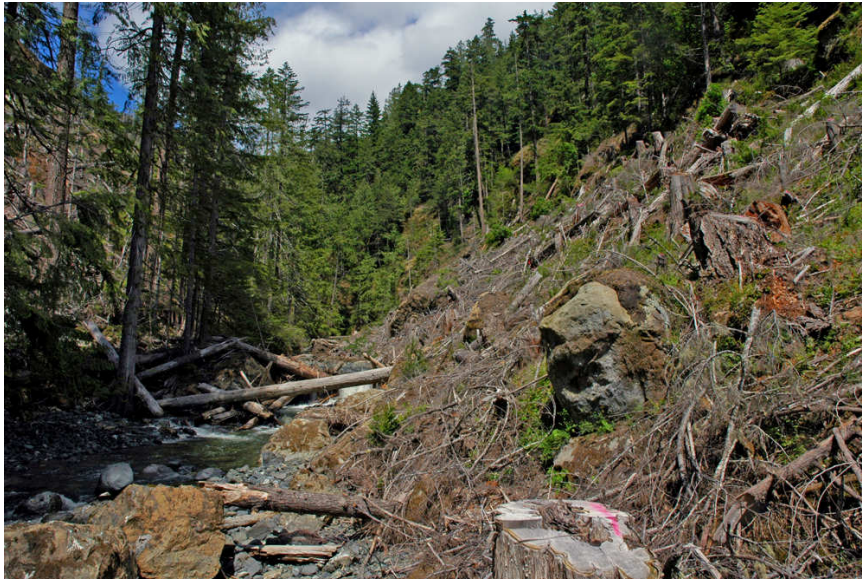
Photo 2 Looking upstream Beech Creek at the harvested riparian area within the Block. The bank consists of large boulders and bedrock out-croppings.

Although trees growing on the channel banks were harvested along the left bank of Beech Creek there was very little evidence of stream bank instability. This section of the stream channel is confined by bedrock and large colluvial boulders (Photo 2 and 3).

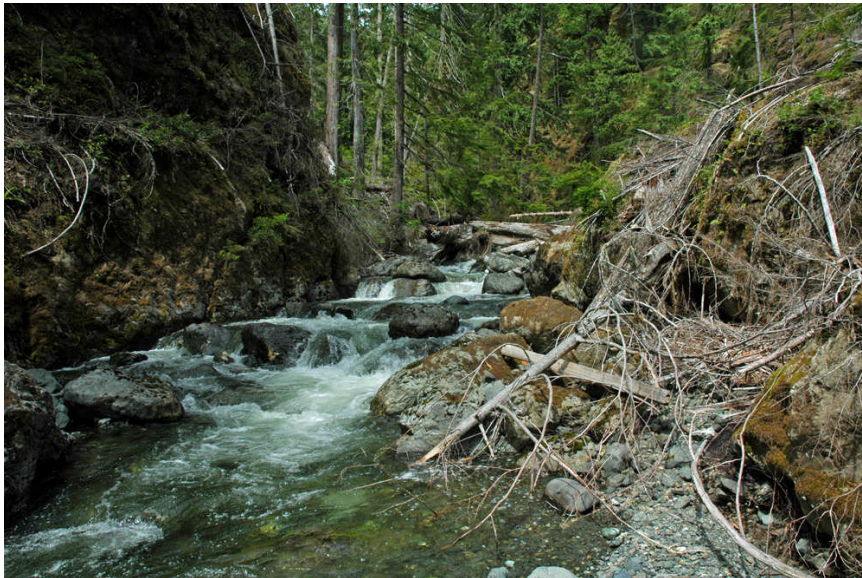
Photo 3 Looking upstream at the Beech Creek channel near the upstream limit of the Block. The channel is confined by bedrock on both sides.

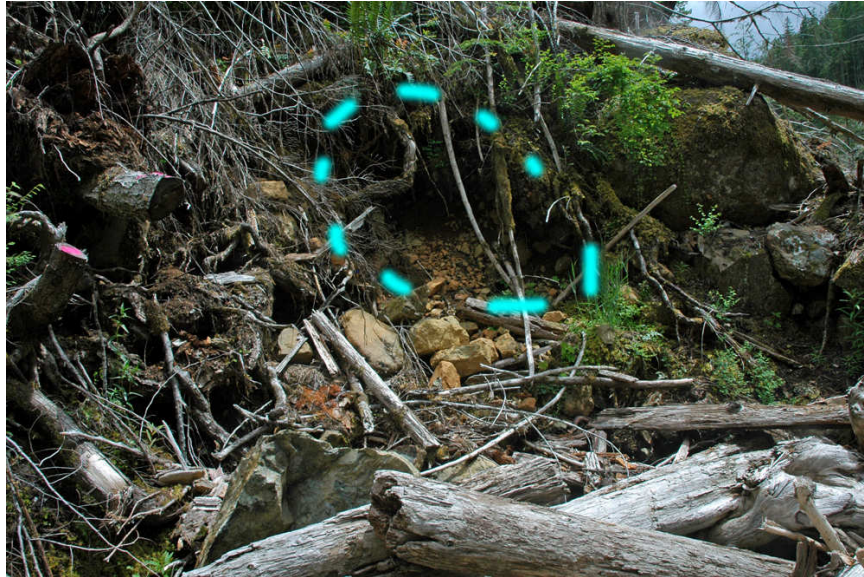
The banks of Beach Creek are stable due to the nature of the bank material. I observed one area where some minor bank, or slope, slumping had occurred (Photo 4). This slumping was small (4 square meters), did not appear to be related to water scour since it was above the average highwater mark, and may have occurred during falling or yarding. Finally, it did not appear that further slumping or bank failure would occur.

Photo 4 Small (4 m²) of bank/slope disturbance likely related to falling or yarding.

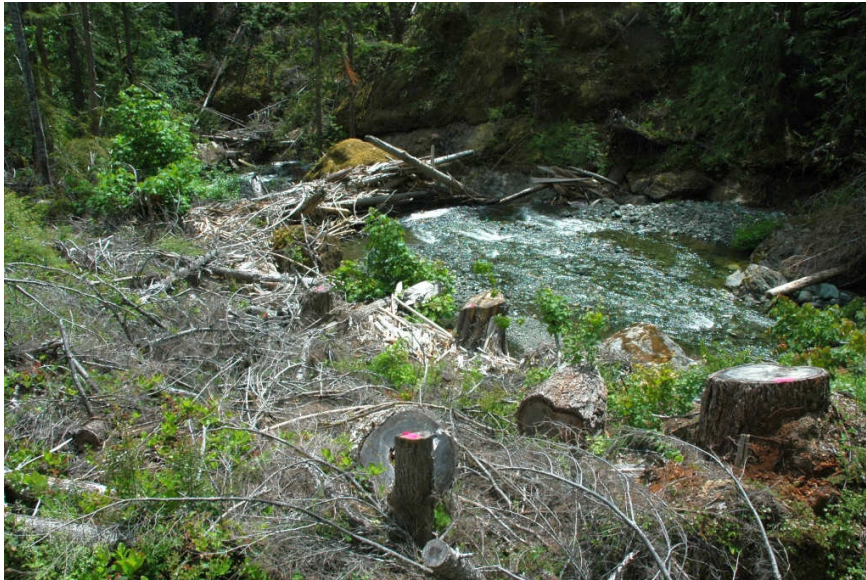
For the purposes of this report, the section of Beech Creek channel within the Block is classified as semi-alluvial. LWD is functioning to store sediment within the channel. There were two log jams within the Block section that were substantial enough to have sediment deposits upstream. Photo 5 and 6 show the two log jams. The log jam in Photo 5 is located at the downstream end of the Block. The Photo 6 log jam is at approximately mid-block.

Photo 5 Log jam at the downstream end of the Block. Sediment storage upstream of the jam.

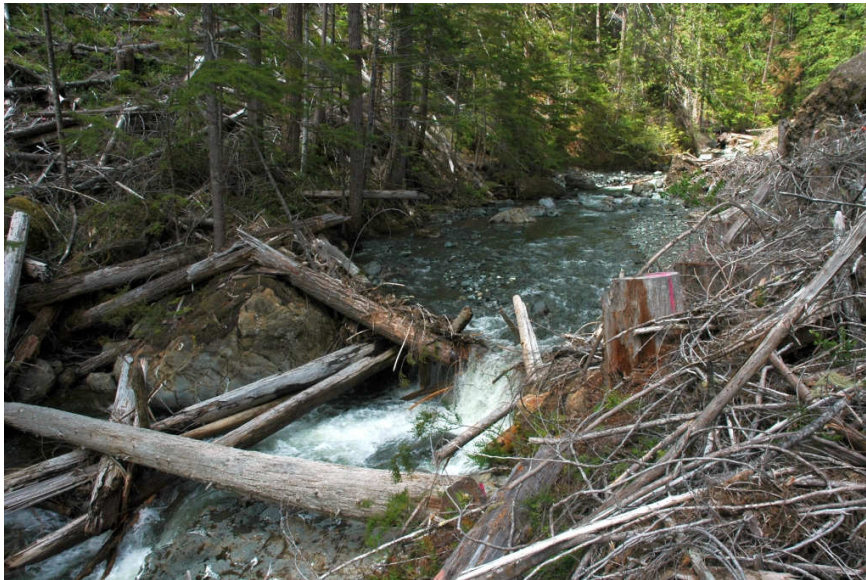
Photo 6 Log jam in the middle of the Block with the sediment wedge just upstream (see Photo 7). Trees retained along the right bank during previous harvesting are visible on the left side of the photo.

(approx. 100 years). Trees were retained along the right (west) bank during recent harvesting on the west side of the Creek (Photo 6). These trees have the potential to provide some future LWD input to the stream. This LWD input may be sufficient to maintain sediment storage in the channel.

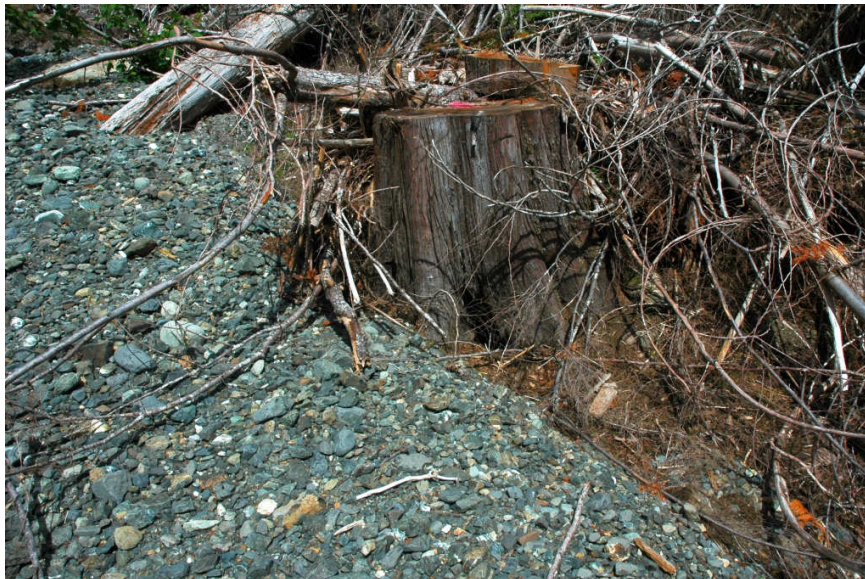
It is also possible that LWD recruitment may be insufficient to maintain the log jams. If so, the log jams will eventually fail as the wood rots. The log jams could fail over a period of years, or during a single flood event. If the log jams were to fail and LWD recruitment is insufficient to form new ones, sediment stored upstream of the log jams (Photo 7) will be flushed downstream.

Photo 7 Close up view of sediment stored by log jam. Log jam is located several meters downstream.
