Erosion Assessment Block T141 – Beaufort Range

February 19, 2008

DOSSIER 07.0486

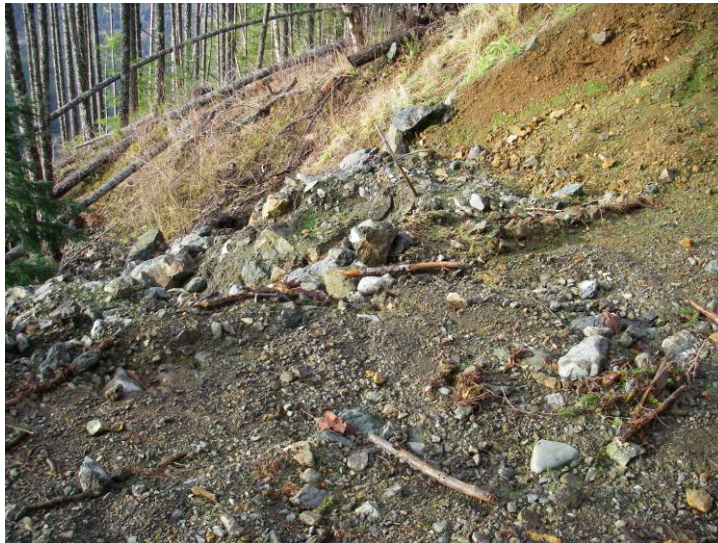
C1 crossing (Stream 4). This is a ford crossing. No significant erosion has occurred, nor was water diverted outside of the natural channel. There was some minor rill erosion on the road surface on the uphill side, and some minor sheet erosion on the ford base. The base appears to be largely armoured now and I expect little additional sediment production. Grass/legume seeding has been done, with relatively little 'catch'. I suggest that no additional action is necessary here; the structure has an effective swale and has performed well.

FIGURE 1. SHEET EROSION ON FORD BASE AT CROSSING C1 (STREAM 4). THE SURFACE IS NOW 'ARMORED' AS MOST ERODIBLE SOIL HAS BEEN REMOVED.

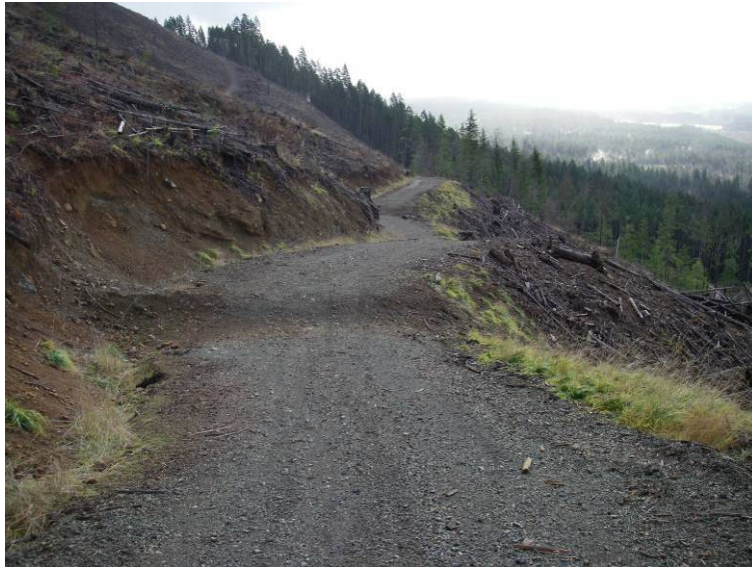
The section of road climbs across a sidehill of about 45 to 55%. During deactivation in 2006 much of the fill was pulled back with the spoil placed into the cut, and cross-drains were placed against the cut to prevent drainage build-up along the road. Disturbed ground was seeded with a grass/legume mix. Grass cover on the fill and on the ditch-lines is helping to reduce erosion but is not complete. I expect the grass cover will continue to increase next spring. The grass cover is adequate but should be augmented with additional seeding.

FIGURE 2. ROAD BETWEEN C1 AND C27. DEACTIVATION IS APPROPRIATE AND HAS SUCCESSFULLY WEATHERED ITS FIRST YEAR. SEEDING IS ADEQUATE.

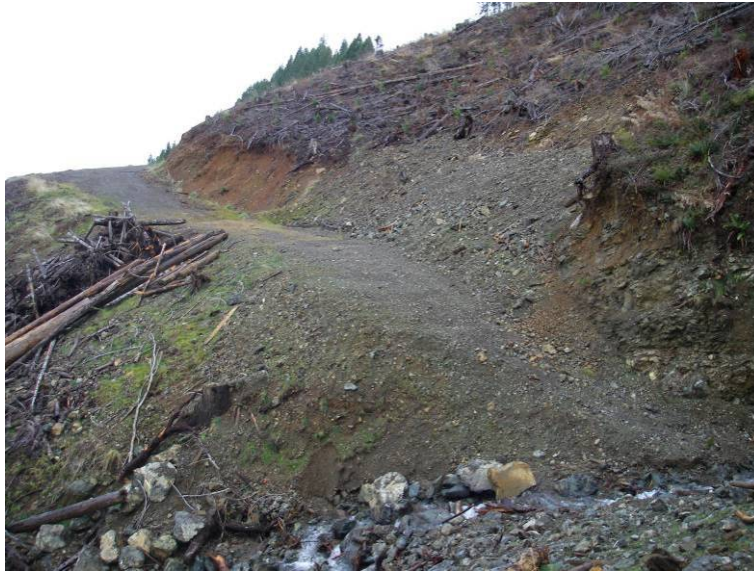
In the November 15, 2006 storm, this crossing was badly damaged. The original 1200 mm pipe was washed out, and a substantial amount of sediment was deposited on the road. Since then TimberWest has completely deactivated the crossing, removing the pipe and pulling back part of the fill at the crossing and along adjacent sections of road. This fulfills expectations of a “restore natural crossing” prescription and represents an appropriate response to the damage. The remaining road on the downgrade side of the crossing is suitable for ATV traffic only. There has been some minor slumping in the sidewalls of the cross-ditch in the original roadfill, but this would have been difficult to avoid completely. The cross-ditch is now sitting at a gradient that is sufficiently steep to avoid significant additional sedimentation.

FIGURE 3. C27 CROSSING LOOKING TOWARDS THE NORTHWEST. THE CROSSING HAS BEEN RESTORED TO NATURAL CONFIGURATION AND SPOIL WAS PULLED AND PLACED AGAINST THE CUT. THE CROSSING HAS BEEN ERODED BUT IS NOW PROPERLY GRADED AND SHOULD NOT PRODUCE SUBSTANTIALLY MORE SEDIMENT.

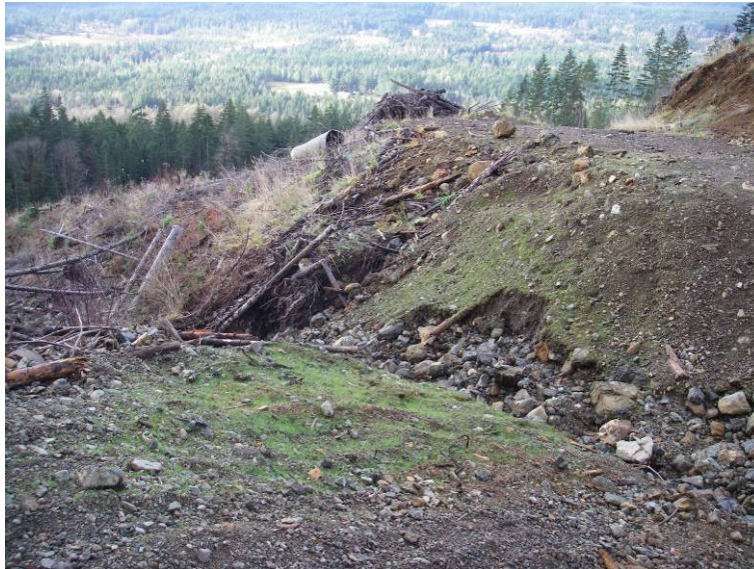
The mainline road switchbacks tightly just beyond C23. During the November, 2006 storm water from Stream 9 at C24 was diverted into the ditch and followed the switchback, discharging back into the natural channel at C23. Both C23 and C24 have been properly deactivated since the storm and both are now functioning well. Water is no longer diverted into the ditch. The ditch itself has been graded and seeded, although the 'catch' is not yet complete. The restored crossing at C23 has been eroded and minor slumping has occurred. I expect that some additional erosion will occur, but it will be minor. The channel base is largely armoured.

FIGURE 4. C23. NOTE SLUMPING ALONG THE BANKS OF THE CROSS-DITCH. THIS DITCH SHOULD HAVE HAD A STEEPER GRADIENT, BUT IT SHOULD NOT PRODUCE SUBSTANTIALLY MORE SEDIMENT. NOTE THE SEEDING ON THE OUTSIDE OF THE ROAD. COVER WILL LIKELY INCREASE NEXT YEAR.

In several cases, the bases of installed cross-ditches had gradients that were gentler than the gradient of the natural channels. As a result, the ditch bottoms eroded, leading in some places, to undercutting of banks. This could also have been lessened by armouring the bottoms of the cross-ditches, or by restoring natural stream gradients.

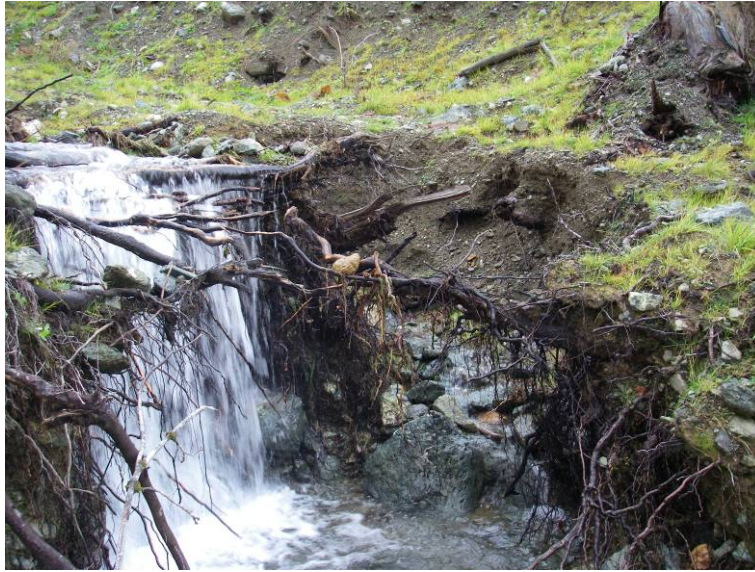
This is a large crossing that experienced substantial scour and deposition during the November, 2006 storm. TimberWest has cleared most of the aggraded sand, gravel and woody debris from the stream channel above the crossing. It has also constructed a berm to re-train the creek back into its original channel and cross-ditched the road. However, it had not removed the 1200 mm pipe.

The structure has been performing well so far this fall and there was no evidence of channel diversion, blockage or erosion of the road prism. However, the stream channel upstream of the culvert was eroding back to a new bed level (the result is a small 'waterfall' about 1 m high). I expect the channel to continue this upstream retreat as it regrades (Figure 5).

At this time, the channel bed erosion at a 'knickpoint' above the road (Figure 5) is generating some suspended and bedload sediment.

FIGURE 5. LOOKING UPSTREAM FROM C20 CROSSING (STREAM 6). TIMBERWEST HAS CLEARED THIS AREA OF SANDS, GRAVELS AND WOODY MATERIAL DEPOSITED IN THE NOVEMBER 2006 FLOOD. THE CHANNEL IS RE-GRADING TO A NEW, LOWER BASE LEVEL (SMALL 'KNICKPOINT' AT LOWER LEFT). THIS WILL CONTRIBUTE TO GENERATE SOME ADDITIONAL SEDIMENT UNTIL IT STABILIZES.

I recommended to TimberWest that they remove the culvert, and I understand that this is planned. I also suggested they consider planting of suitable shrubs and/or trees (e.g., willow cottonwood, red alder, or maple) on the aggraded sediment upstream of the crossing for future sedimentation control. I suggest TimberWest also places coarse rock in the channel downstream of the 'waterfall', to slow the rate of upstream channel erosion.

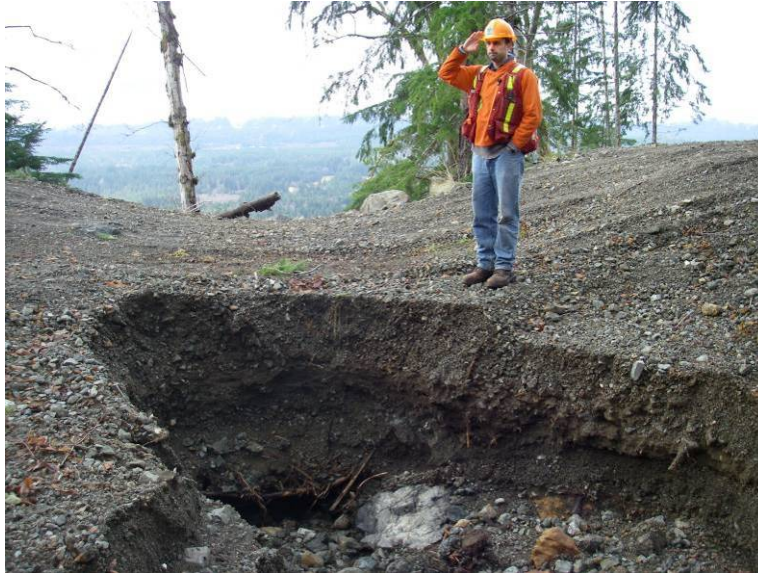
TimberWest left this 800 mm pipe in place, but installed a cross-ditch above it. During the November 2006 storm, the creek initially scoured all the roadfill around the pipe (and probably moved it a few metres downstream), then buried it with new alluvial material. I was not aware of this sequence of events during my earlier inspection because the pipe was completely buried. Erosion of the road prism was restricted in part because TimberWest had placed coarse angular rock on the fillslope around the outlet of the culvert. Recent storms had eroded the fill around in the intake (Figure 6). The pipe is still functioning, but the road fill around the intake is actively eroding and producing sediment. I suggested that TimberWest remove this culvert and restore the natural stream channel gradient. I understand that this has already been done.

FIGURE 6. EROSION AROUND PIPE INTAKE (THE INTAKE IS AT THE BOTTOM OF THE HOLE) AT CROSSING C18. THE PIPE SHOULD HAVE BEEN REMOVED IN DEACTIVATION AND THE ORIGINAL CHANNEL GRADIENT RESTORED, BUT THIS HAS SINCE BEEN DULY COMPLETED (D. IANNIDINARDO, PERS.COMM).

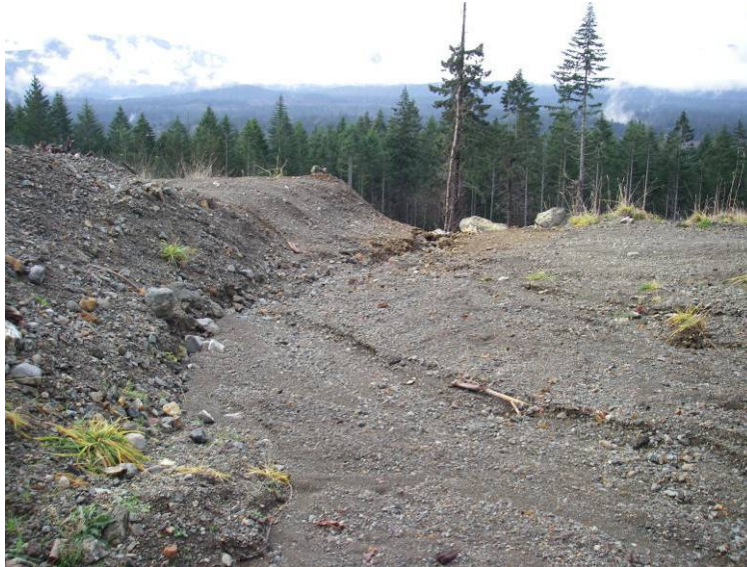
C11 contained a 1000 mm pipe that accommodated the flow from Stream 4. It was buried by an alluvial deposition during the November 2006 storm. Since then TimberWest has excavated a channel, and installed a berm on the down-grade side. Recent stormflows have resulted in minor erosion on the fan surface resulting in rills up to 15 cm deep. This is a minor sediment source that will continue to erode until the channel bed becomes naturally armoured. The culvert remains in place and appears to be performing well.

FIGURE 7. LOOKING DOWNSTREAM AT C11. TIMBERWEST HAS EXCAVATED A CROSS-DITCH AND INSTALLED A BERM ON THE DOWN-GRADE (LEFT) SIDE. SOME EROSION IN THE FORM OF RILLING HAS OCCURRED ON BASE OF THE DITCH; THIS IS A RELATIVELY MINOR SOURCE OF SEDIMENT. THE CULVERT REMAINS IN PLACE, SO IT SHOULD BE MONITORED FROM TIME TO TIME.

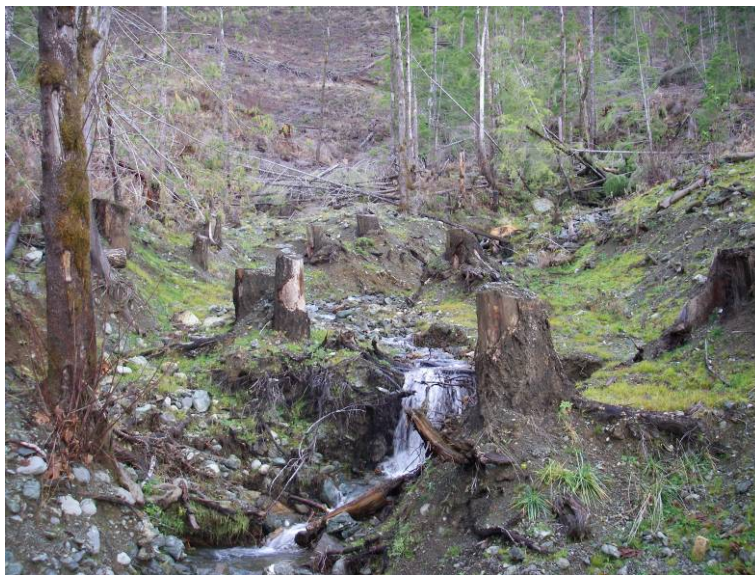
A potential sediment source exists at the Stream 6 crossing C20. The channel is eroding its bed upstream of the crossing; the loss of riparian vegetation due to storm damage last year will result in this continuing unabated.

Figure 8. C20 upstream (Stream 6). TimberWest cleared a large amount of debris from this reach, spoiling it to the right (southeast) in a berm to prevent stream capture by the road. This has created an area of potential sediment production in the future. Note the 'waterfall' in the foreground.

I suggest some planting whips of willow, cottonwood, red alder, bigleaf maple, or other suitable shrubs or trees upstream of one of the Stream 6 crossings; this will increase the likelihood of mitigating future stream erosion (Figure 8). Additionally, TimberWest might consider placement of coarse, angular rock in the channel downstream of the 'waterfall', may slow the rate of retreat, and thus sediment production.
