**Investigation: Road Construction Practices on
Block T141 Managed Forest #7
Beaufort Range Port Alberni**

Owner: TimberWest Forest Corporation

Investigation: IN05019 Beaufort Block T141

Date: February 28, 2006

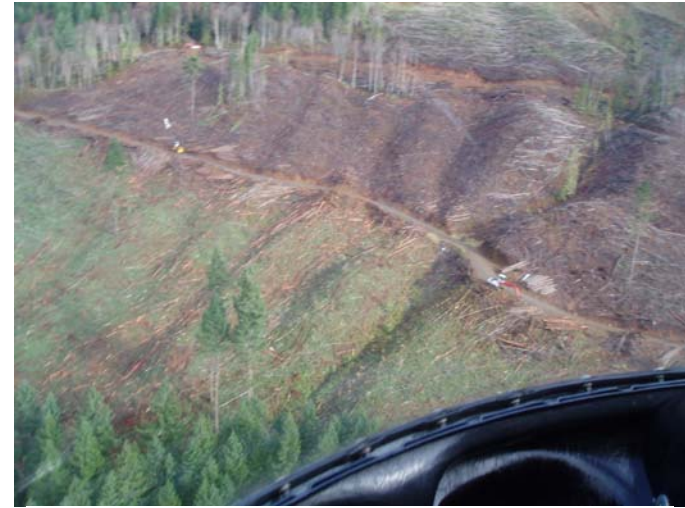
Overview of south west corner of block showing stream 4 and the replaced crossing C-11.

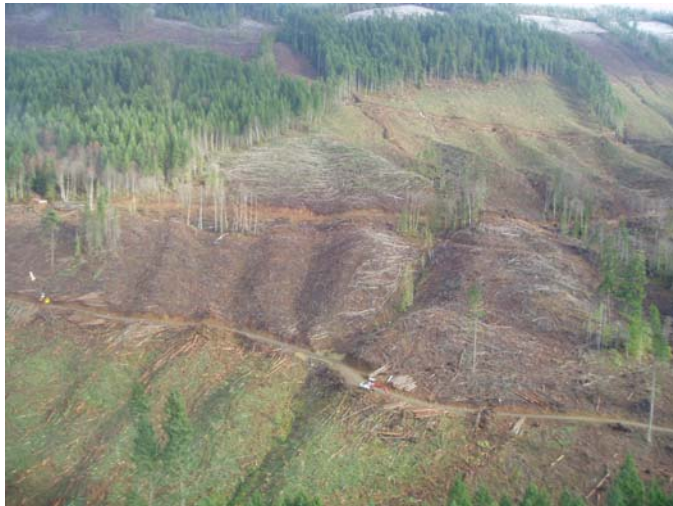
Overview showing stream 4, the replaced crossing C-11, the old skid road below crossing C-18 and stream 6.

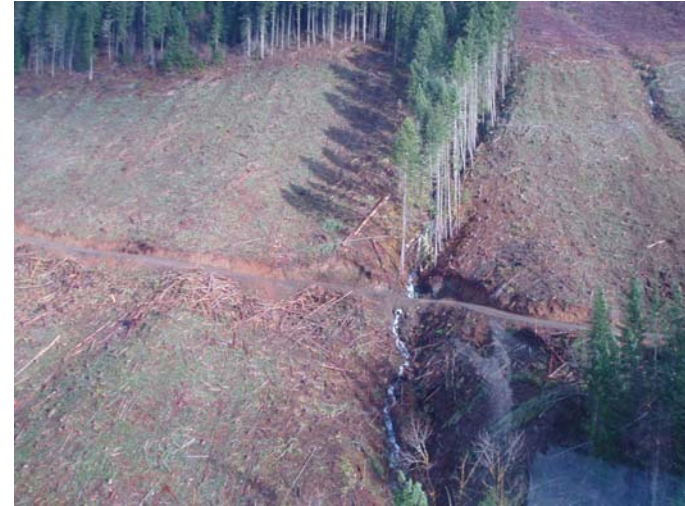
Crossing C-27 on stream 6 with stream reserve above.

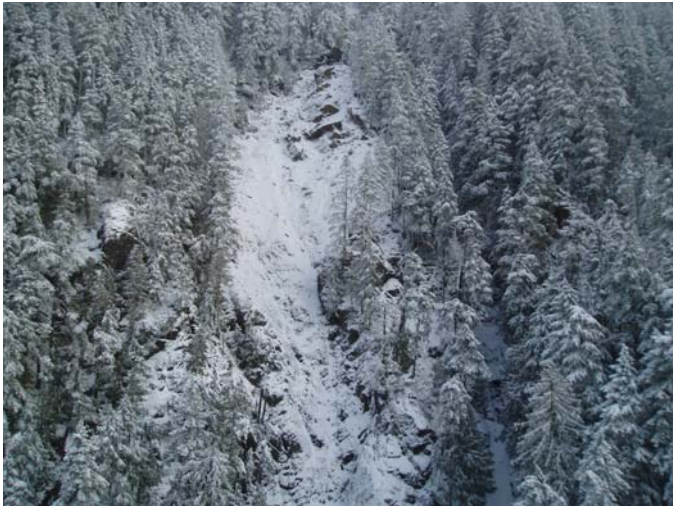
Origin of slide at high elevation.

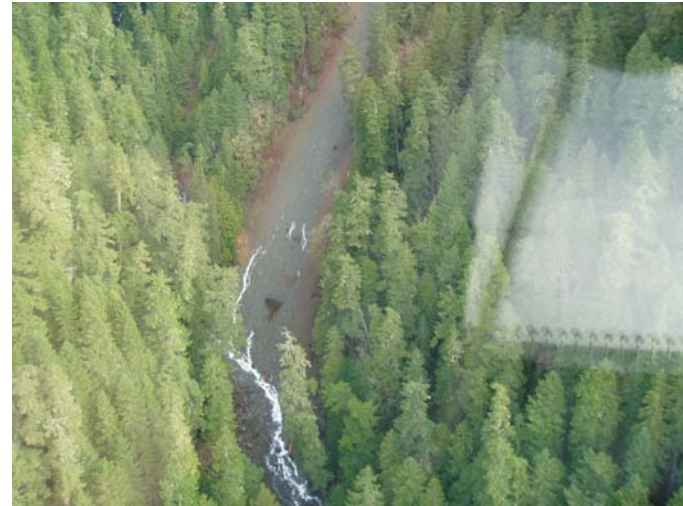
Hal Creek slide in natural timber.

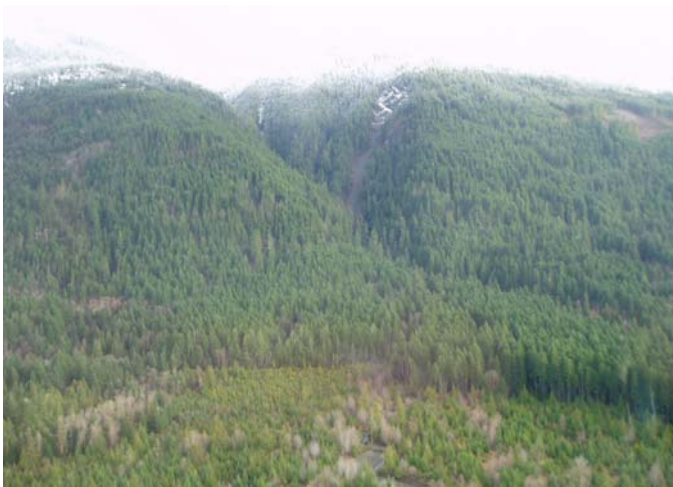
Natural occurring slide in the head of Hal Creek, not associated with any logging.

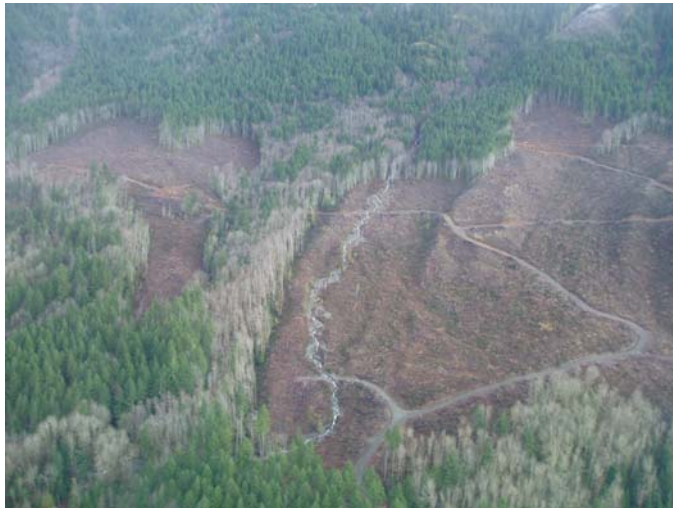
Slide through block T172.

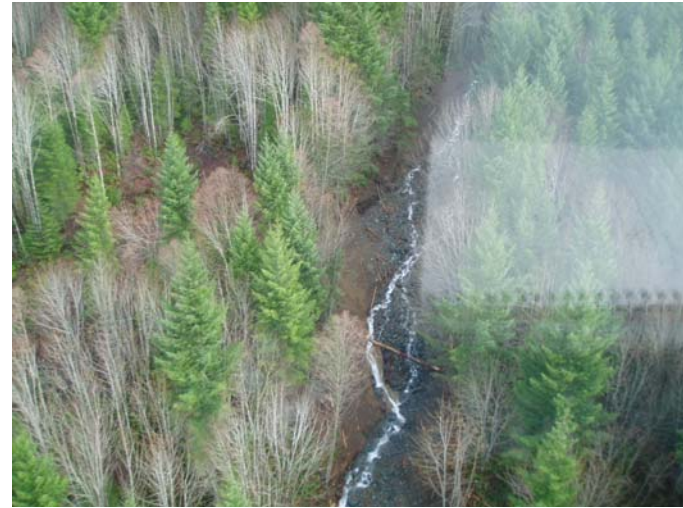
Slide above block T172.

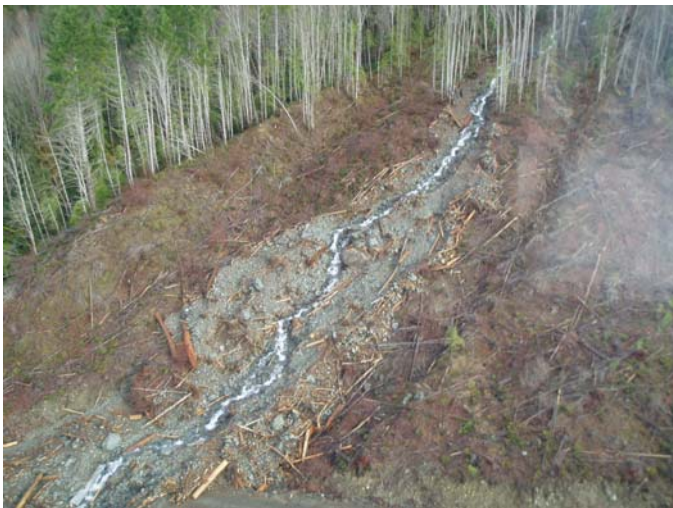
Run out of slide onto block T172.

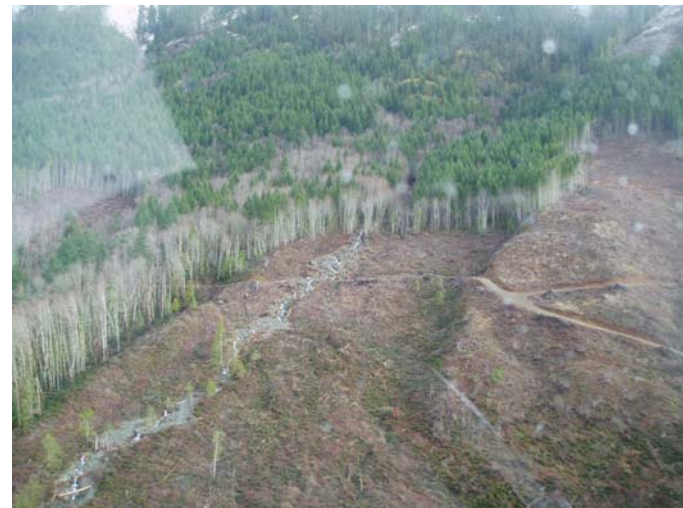
Slide debris on block T172.

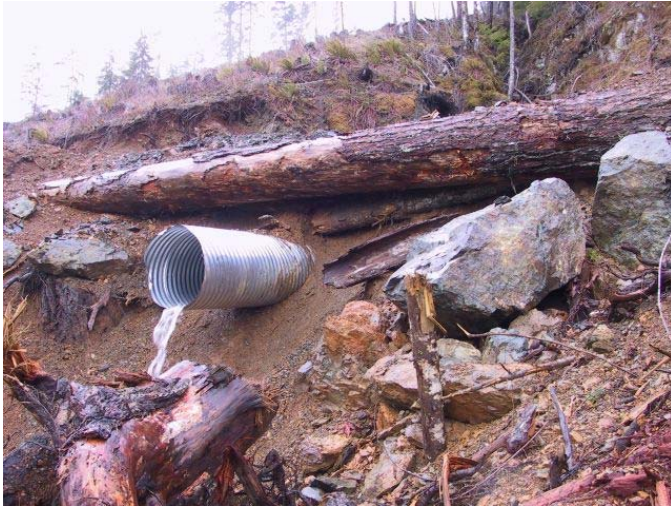
Section 10 Plate 1 shows the culvert outlet. The culvert pipe barely protrudes beyond the road fill. There is insufficient protection of the road fill placed around the culvert, allowing sediment to erode into the stream. The quantity of sediment that entered stream 4 at this location is not estimated.

Outlet of culvert C1 (upper culvert) on stream 4.

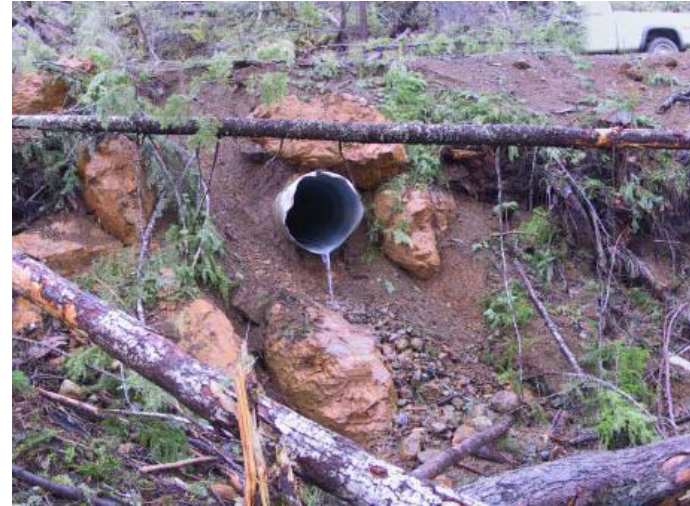
Photo 6 shows the culvert outlet. The outlet is not protected. Road fill placed around and above the culvert has been eroded, resulting in sediment entering the stream. The quantity of sediment that entered the stream at this location is estimated.

Outlet of culvert C18 (middle culvert) on stream 4.

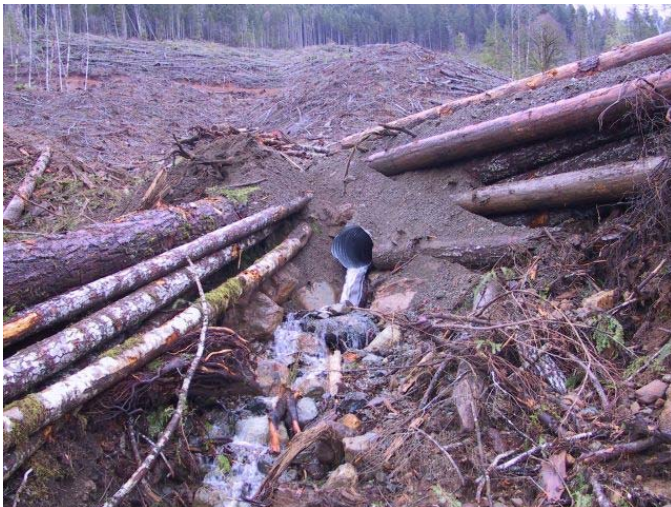
Photo 40 shows the condition of the culvert outlet. Road fill around the fill can be seen to be eroding. The culvert is too short, allowing water to erode excavated material at the base on the outflow. There is no protection around the culvert to prevent erosion of the fill. The fill slope beside the culvert is buttressed by logs and compacted material to provide stability to the road surface. The lack of protection around the culvert outlet has allowed road fill to erode and enter the stream.

Outlet of culvert C11 (lower culvert) on stream 4.

Mr. Hamilton's report on pages 27 and 28 and in photos 36 and 37 shows the condition of crossing C-11 on January 31, 2006 after a new 1000mm diameter metal culvert was installed. This is a textbook example of a well-installed culvert. The inlet has a deep catch basin and is amply protected with rock riprap. On the outlet side the fill has been sloped and riprapped with rock. The culvert is properly angled so that the water flow is dispersed on the riprap. Both sides have been grass-seeded to provide stability.

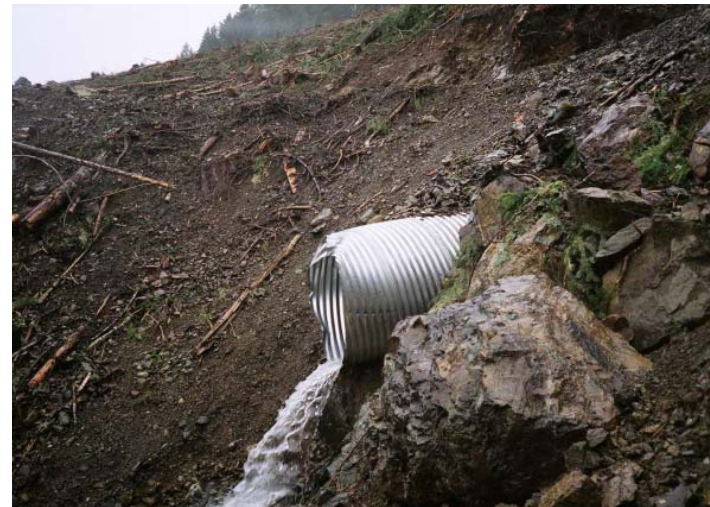
Photo 22 shows the condition around the culvert outlet. There is no protection of the road fill and road fill is able to erode into stream 6.

The normal practice in conditions on the coast where erodible material is encountered is to employ measures when installing culverts that ensure the outflow does result in erosion of the road fill and to stabilize the fill slope around the culvert outlet. The measures employed by the Owner at all four crossing locations do not conform to generally accepted road construction practices in similar soil conditions. (Reference - The Handbook of Best Management Practices for Private Forest Land in British Columbia 2001)

Outlet of culvert C27 on stream 6.
