CK106 Block Assessment Kweishun Creek

- TimberWest Forest Corp. -

Block Assessment of CK106 Kweishun Creek TimberWest Forest Corp.

November, 2007

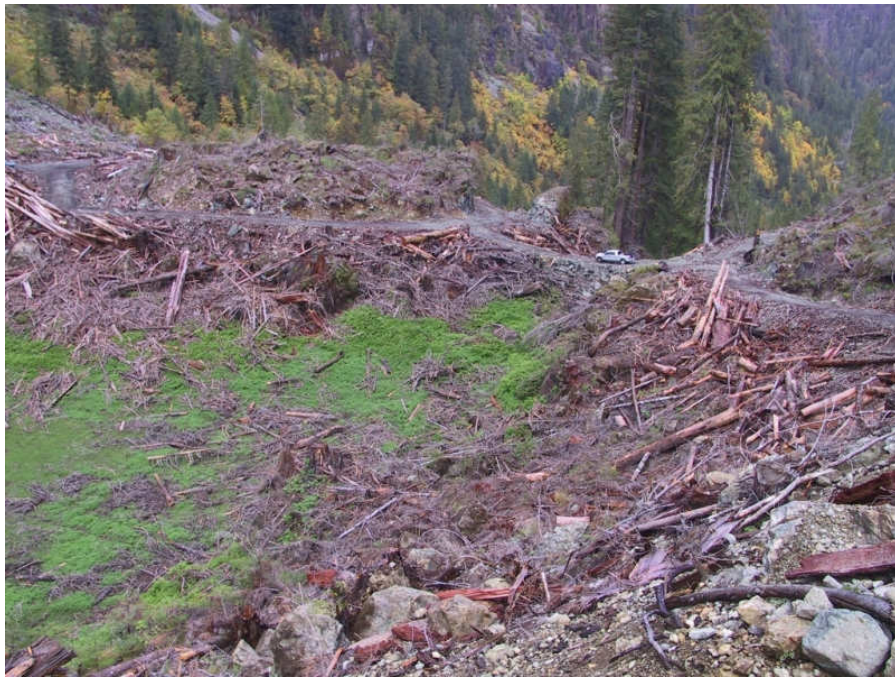
Photo 1 Looking downstream at the colluvial constriction, or dam, on Kweishun Creek. During extreme high flows, the Creek flows over this deposit where the truck is parked and then down to Rees Creek.

Naturally occurring slides, rock falls (colluvium), and debris flows (Photo 1) have formed a constriction, or “dam”, across the valley near FC 1 and FC 25 (Figure 1). This “dam” prevents alluvial (sediment moved and deposited by flowing water) sediment (i.e. sand, gravel, etc.) from being transported downstream by Kweishun Creek during peak flows. Over the years this sediment has been deposited upstream of the constriction and a relatively flat area of deposited sediment comprised mainly of gravel and sand has formed (Photo 2).

The lower road crossing (engineered ford) of Kweishun Creek (Photo 1) was constructed by placing about one meter of rock fill on top of the overflow outlet area. It is therefore recommended that this fill be removed once harvesting activities have been completed in order to restore the natural drainage regime of the Creek. No other remediation is recommended.

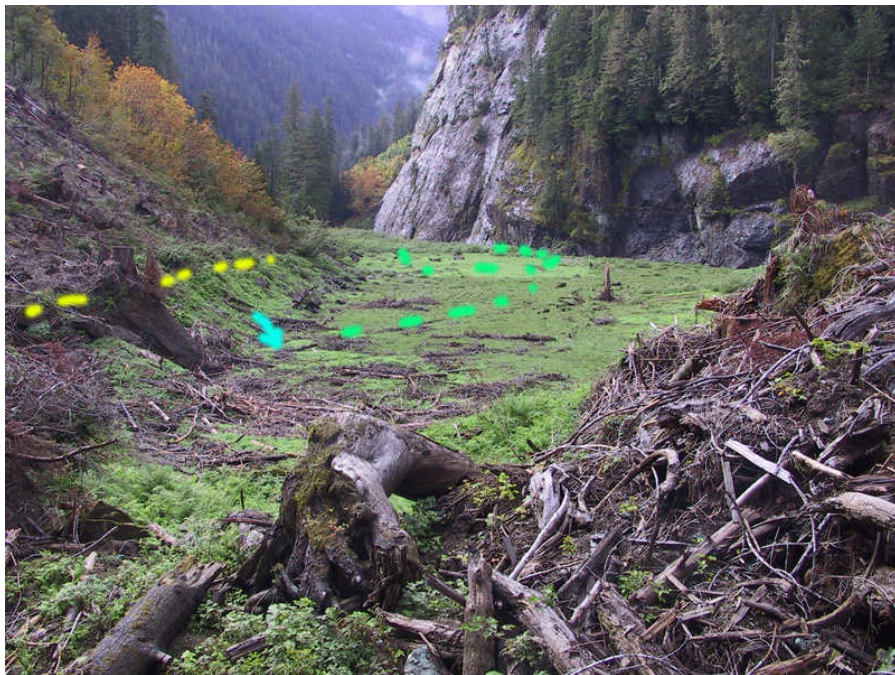
Photo 2 Looking upstream at Kweishun Creek from colluvial constriction. The green dashed line shows the approximate location of the stream channel. The blue arrow indicates where the stream goes sub-surface. The yellow dashed line indicates the approximate high water mark.

Kweishun Creek flows into the meadow and becomes multi-channelled (Photo 3). The stream width was measured at six locations near FC55 to determine average channel width. The average channel width was 3.3 m. The stream flows through the meadow towards the colluvial constriction and then flows directly into the ground at a location south of FC 25 (Photos 2 and 4).

It is therefore my opinion that Kweishun Creek within the Block is a stream that is temporarily flooded during high flow periods and that it is not a true lake. The area adjacent to the stream that is flooded is best described as an ephemerally or seasonally flooded meadow². The stream itself is the approximately 3.3 m wide channel that has been scoured in the meadow by flowing water (located at green dotted line in photo 2). The annual high water mark, or edge of trees shown with a dotted yellow line in photo 2, delineates the extent of the floodplain and this is not considered the edge of the stream channel.

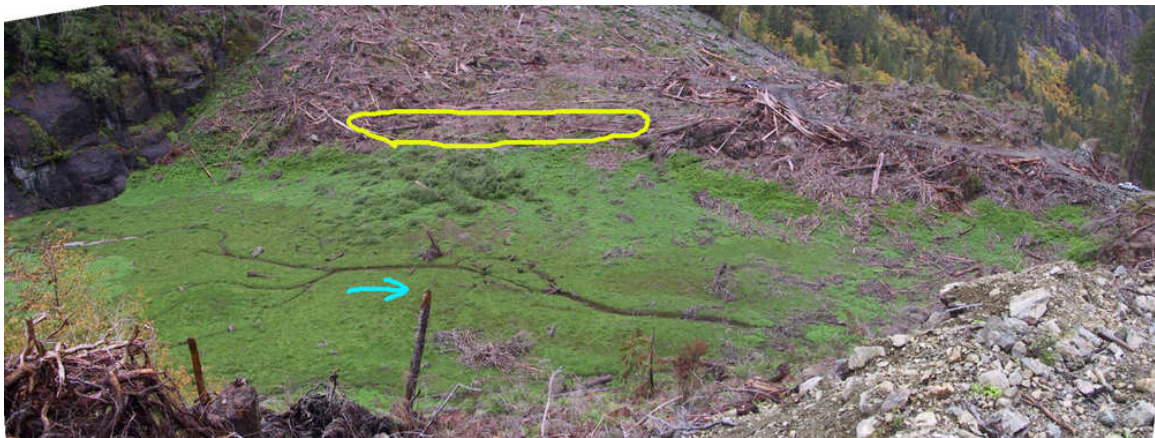
Photo 3 Kweishun meadow that is subject to periodic flooding. Blue arrow shows the direction of stream flow. Approximate location where cedar trees were felled into water circled in yellow between FC1 and FC2.

Section 17 states that an Owner must not damage a pond, wetland, or seasonally flooded depression with accumulations of woody debris or by physical disturbance. A significant portion of Kweishun Creek within the Block was walked and the falling boundary between FC1 and FC2 was inspected. This is the area where large cedar trees were felled into the flooded meadow area of Kweishun Creek.

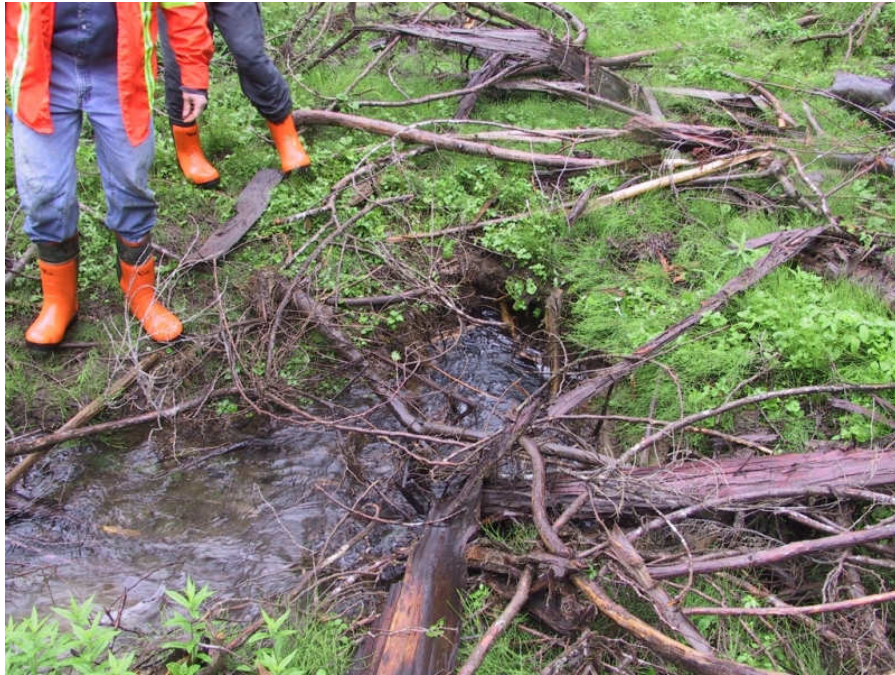
Photo 4 Location in the meadow where Kweishun Creek flows into the ground. This site is shown in Photo 2 with a blue arrow.

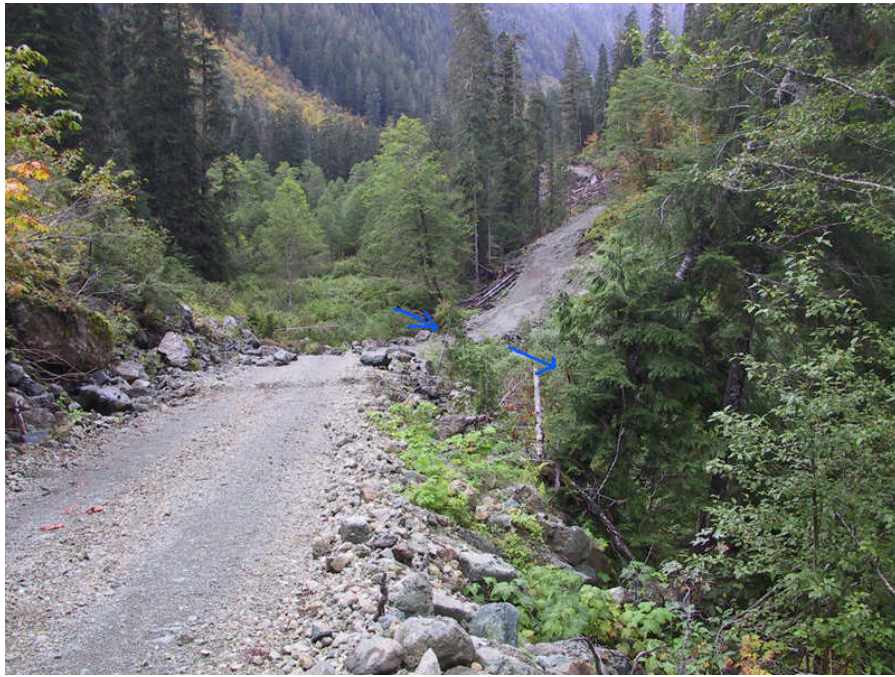
No harvesting was conducted within five meters of the stream channel since trees are not present in this area. The upstream road crossing was constructed over Kweishun Creek near FC60 (Photo 5) but understory and non-commercial vegetation appeared to have been retained as much as possible within five meters of the stream. I saw no evidence of either harm of fish (if present) or fish habitat. There was also no indication that water quality was or will be materially reduced as a result of these activities.

Photo 5 Looking at the upper road crossing of Kweishun Creek (channel location marked with blue arrows).

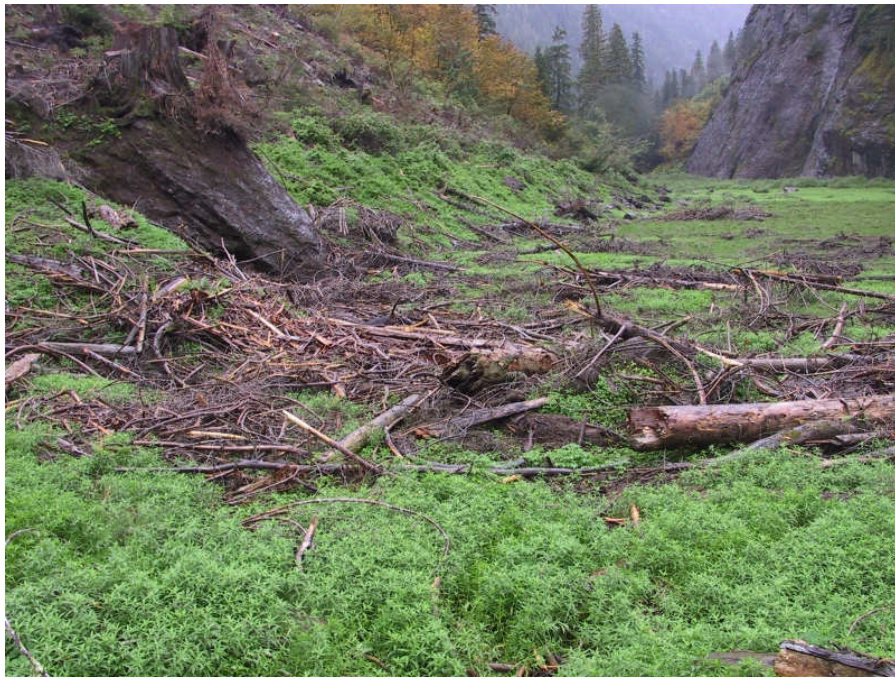
There was numerous accumulation of woody debris in the meadow area, particularly near the alluvial constriction (Photo 6). Not all of this debris was from harvesting activities since pre-harvest photographs supplied by TimberWest show substantial natural accumulations. Although there is a substantial volume of small woody debris, it is my opinion that this material does not pose a significant risk to downstream water quality.

There was no indication that the woody debris was causing, or would cause, accelerated erosion of the stream channel or banks. Some woody debris may be transported to downstream reaches of Kweishun Creek during extreme high water but I do not anticipate that this would cause a measurable decrease in water quality or a negative impact to downstream fish habitat.

Photo 6 Accumulations of woody debris in the meadow area.

Any attempt to remove the accumulation of small woody debris from the meadow area would likely result in a significant amount of ground disturbance if done by machine. This ground disturbance could result in erosion and the delivery of suspended sediment to Kweishun Creek. Furthermore, it is my opinion that this debris does not pose a significant risk to the downstream fisheries resource. It is therefore recommended that debris removal from the meadow area is not undertaken.

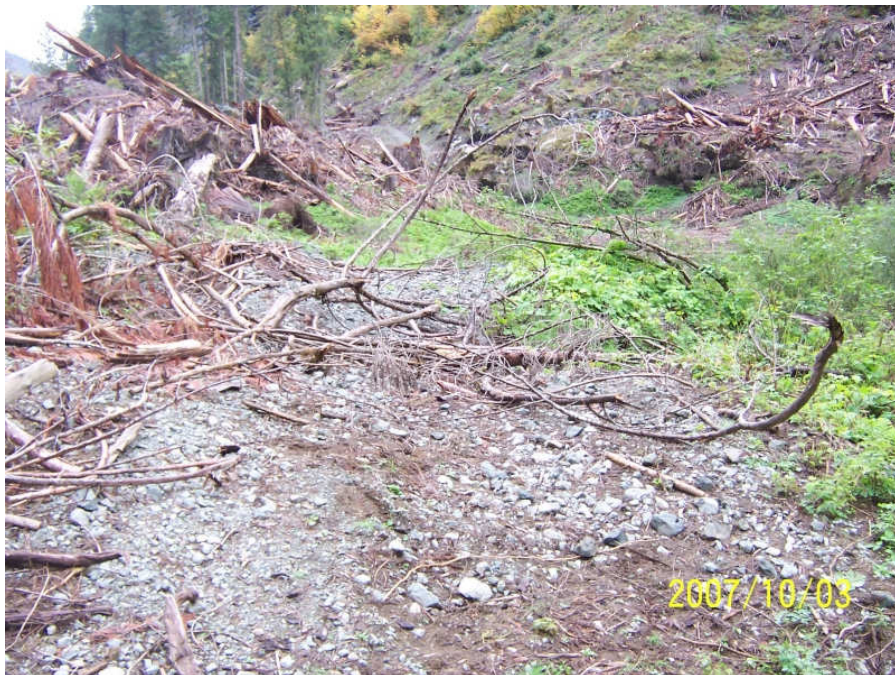
There was no evidence of ground disturbance resulting from falling and yarding other than an isolated area near FC2 (Photo 7). The ground disturbance near FC 2 was a shallow depression in an exposed area of gravel (this area is on an alluvial fan) and there was no evidence of soil erosion or the off-site movement of sediment. As stated in Section 7.2, the accumulations of woody debris also did not, in my opinion, constitute damage to the seasonally flooded area.

Photo 7 Area of exposed gravel between FC1 and FC2. No indication of sediment delivery to Kweishun Creek. Photo supplied by TimberWest.
