Landslide Assessment Block T144 – Kitsukis Creek Beaufort Range

Gordon Butt, M.Sc., P.Geo., P.Ag.

March 8, 2007

DOSSIER 07.0016

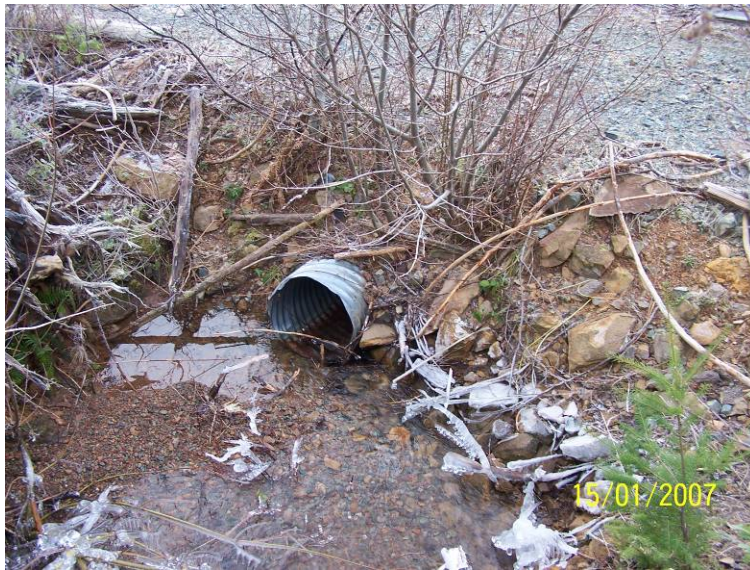
At Sta. 0+407 there was an installed 600 mm corrugated steel pipe (Photo 1) that was effectively accommodated the existing flow from a small creek (Stream 7 on the 1998 lay-out map). The upstream channel lies at about 20% and has a bedrock base, with discrete banks. Below the road the channel was largely obscured by logging debris. The channel steepened considerably downslope, ultimately reaching a gradient of 50 to 60%.

Mr. Hasanen was present shortly after the landslide occurred and found that the culvert had plugged and at least partly cleared the debris from the opening.

The 600 mm culvert at Sta. 0+407 on Spur 200 was inadequate to accommodate the stormflow on November 15, 2006. Fine woody debris (i.e.; a stick) was enough to contribute to the failure. A larger culvert may have been able to convey the floodwater.

FIGURE 1. CULVERT ON SPUR 200 AT STREAM 7. IN THIS PICTURE IT IS FUNCTIONING ADEQUATELY.

In retrospect, I believe that TimberWest should have installed a larger culvert, given the proximity of fish-bearing water and high consequence downstream. However, it is easy to make such decisions in hindsight, and I suspect that most field technicians would be satisfied with a 600 mm pipe under the circumstances. Furthermore, the flow diversion resulting from the failed culvert probably did not make a big difference in the impact, aside from the additional sediment and the site disturbance.

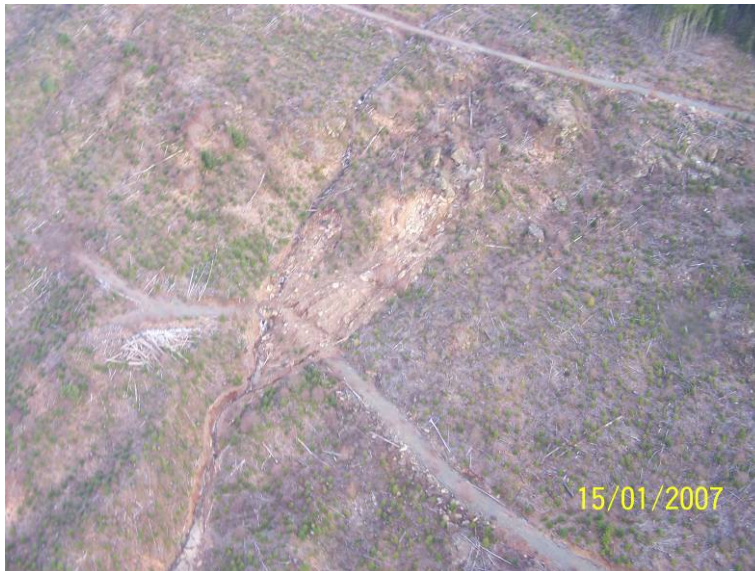
Two debris slides formed downslope of this area (Photo 2). The western one (Slide 1) is adjacent to Stream 7, initiated approximately 75 m downslope of Spur 200. Its proximity to the stream raises suspicions that it may have been triggered by bank erosion just downstream of the existing headwall.

The combined effect of the two landslides was to create a disturbed area in the shape of a triangle about 70 m wide and 125 m long, with the apex at the lower end, in Stream 7 (downstream of Spur 100). The upper part of this triangle consists of the eroded scars below the headwall; the lower two-thirds of the disturbed area consists of a veneer of debris deposited on the native ground surface. Within this lower area there was localized erosion. The estimated area of soil disturbance is approximately 0.9-ha.

FIGURE 2. AERIAL VIEW OF SLIDE SCARS; SLIDE 1 IS THE SMALLER SCAR ON THE LEFT, ADJACENT TO STREAM 7; SLIDE 2 IS THE LARGER SCAR, IN THE CENTRE OF THE PHOTO AND UPSLOPE FROM SLIDE 1. BOTH ARE RELATIVELY SHALLOW DEBRIS SLIDES. NOTE THE TRIANGULAR AREA OF DISTURBANCE.

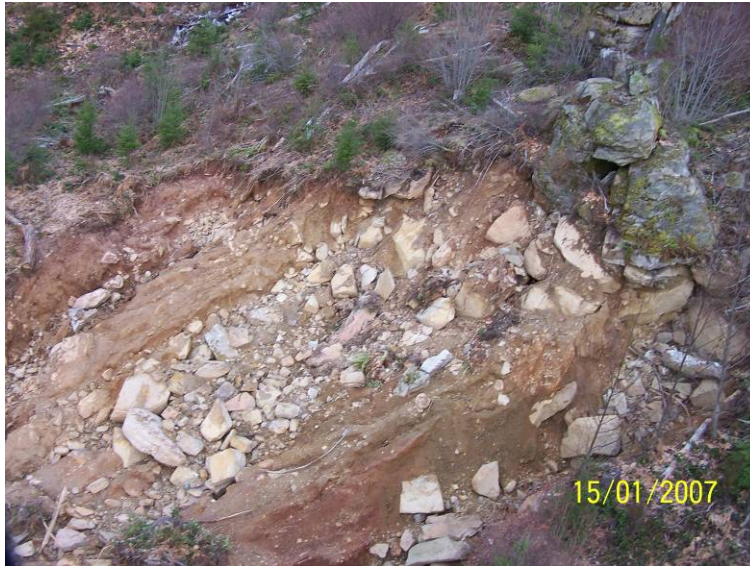
The eastern slide (Slide 2) is larger and contains two headwall lobes. The headwalls (Photo 3) are located just downslope of the rock outcrops, roughly 60 m downslope of Spur 200. Their headwalls expose coarse, bouldery colluvium. There is evidence of localized erosion in the

slide scar from water emanating at the base of the headwall. Mr. Hazenboom, investigating the scars on December 11, 2006 describes subsurface seepages along the failure planes.

The headwalls are located on moderate to moderately steep slopes (60 to 70%) but run out onto more gentle slopes of 30 to 40%. Both slides take the form of a ‘debris slide’ characteristic of relatively shallow translational failures in materials of low cohesion. The debris moved downslope rapidly as a rolling, sliding mass and did not channelize before entering Stream 7. The western slide delivered debris directly into Stream 7 a short distance downslope of the headwall (within 25 m); the eastern slide deposited part of its debris on the open slopes below and on the lower Spur 100, although some part of the debris continued across the road and then into Stream 7 (Photo 4). Perhaps half of the volume of soil mobilized by Slide 2 was deposited on the native ground before entering the stream.

The volume of water diverted along the road and then discharged on the hillslope below Sta. 0+375 travelled along a subsurface route (that is undiscernible from the surface), emerging in deep (and locally steep) colluvial deposits immediately downslope of sandstone outcrops. The surcharge of water was sufficient to saturate these coarse soils and trigger a debris slide (Slide 2). The effect of Slide 2 was to deposit debris over native hillslope and enlarge an already heavily sediment-surge Stream 7 in flood flow.

FIGURE 3. HEADWALL OF SLIDE 2. NOTE LARGE QUANTITY OF BOULDERS IN THIS LOCALIZED COLLUVIAL DEPOSIT, IMMEDIATELY DOWNSLOPE FROM BAND OF EXPOSED BEDROCK KNOBS. THIS TERRAIN UNIT IS NOT REPRESENTATIVE OF THE GENERAL TERRAIN IN BLOCK T144.

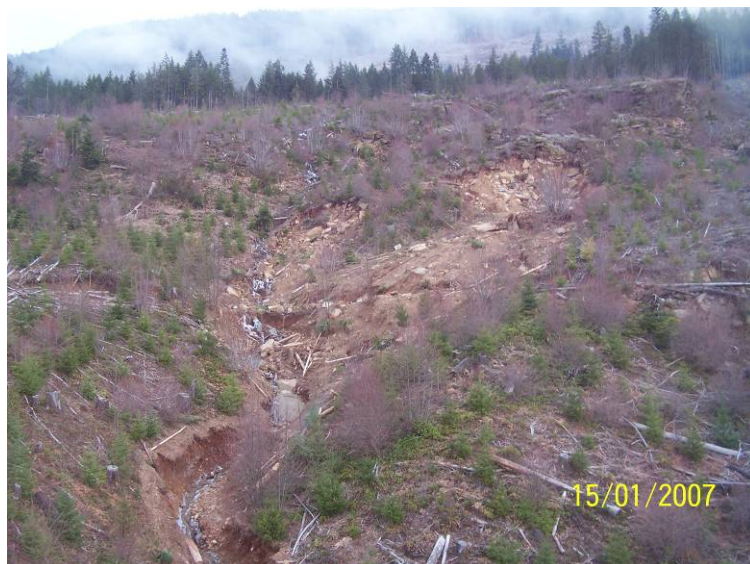
The debris from the two slides – as well as the heightened water flow due to the flood - overwhelmed Stream 7, causing a significant amount of bank erosion which further increased the volume of sediment delivered downstream. The crossing on Spur 100 was unable to accommodate the flow, and the road bed was deeply eroded by water flowing over the running surface.

I conclude that had the culvert on Spur 200 not failed, Slide 1 would still have occurred, and severe erosion of the Spur 100 road and downstream reaches of Stream 7 would still have been scoured. The effect of the diversion on Spur 200 was to increase the amount of sediment transported downstream to the base of the slope. However, damage would likely have occurred without the blockage of the culvert.

FIGURE 4. SLIDE 1 (ON THE LEFT) AND SLIDE 2 (LARGER ONE ON RIGHT). THE DEBRIS FROM SLIDE LEFT A VENEER OF SOIL OVER THE NATIVE SLOPE ABOVE AND BELOW THE ROAD (SPUR 100) RUNNING ACROSS THE MIDDLE OF THE PHOTO. THE REMAINDER OF THE DEBRIS ENTERED THE STREAM BELOW THE ROAD. NOTE THE SCOUR IN THE LEFT BANK OF STREAM 7 IN THE LOWER LEFT PORTION OF THE PHOTO. MUCH (OR MORE) OF THIS WOULD LIKELY HAVE OCCURRED EVEN IF THE CULVERT IN SPUR 200 DID NOT PLUG.

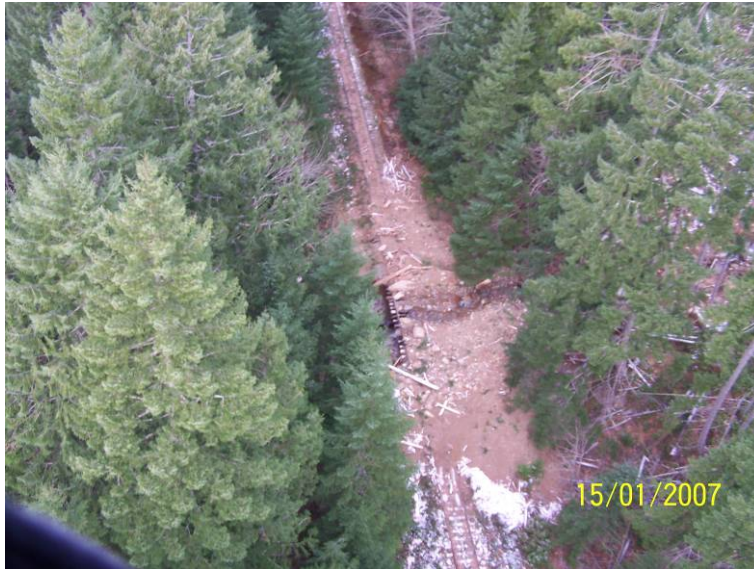
The entire length of Stream 7 downstream from Spur 100 has been affected; in places through severe bank erosion, in other places through localized deposition of sediment in gently sloping reaches. At the E&N rail line, the debris buried the culvert, then water eroded the fill (Photo 5). The same happened again at the Log Train Trail. Sediment was delivered to a tributary of Kitsuksis, and then probably reworked in this channel to be delivered to Kitsuksis itself.

FIGURE 5. THE E&N RAIL LINE; THE CULVERT WAS PLUGGED BY AN INITIAL SEDIMENT-CHARGED FLOW (RISING STORMWATER PEAK), THE WATER DIVERTED OVER THE SURFACE ERODED THE FILL, UNDERMINING THE TRACKS.
