CW500 Block Assessment Beech Creek

- TimberWest Forest Corp. -

Block Assessment of WF500 Beech Creek TimberWest Forest Corp.

July, 2007

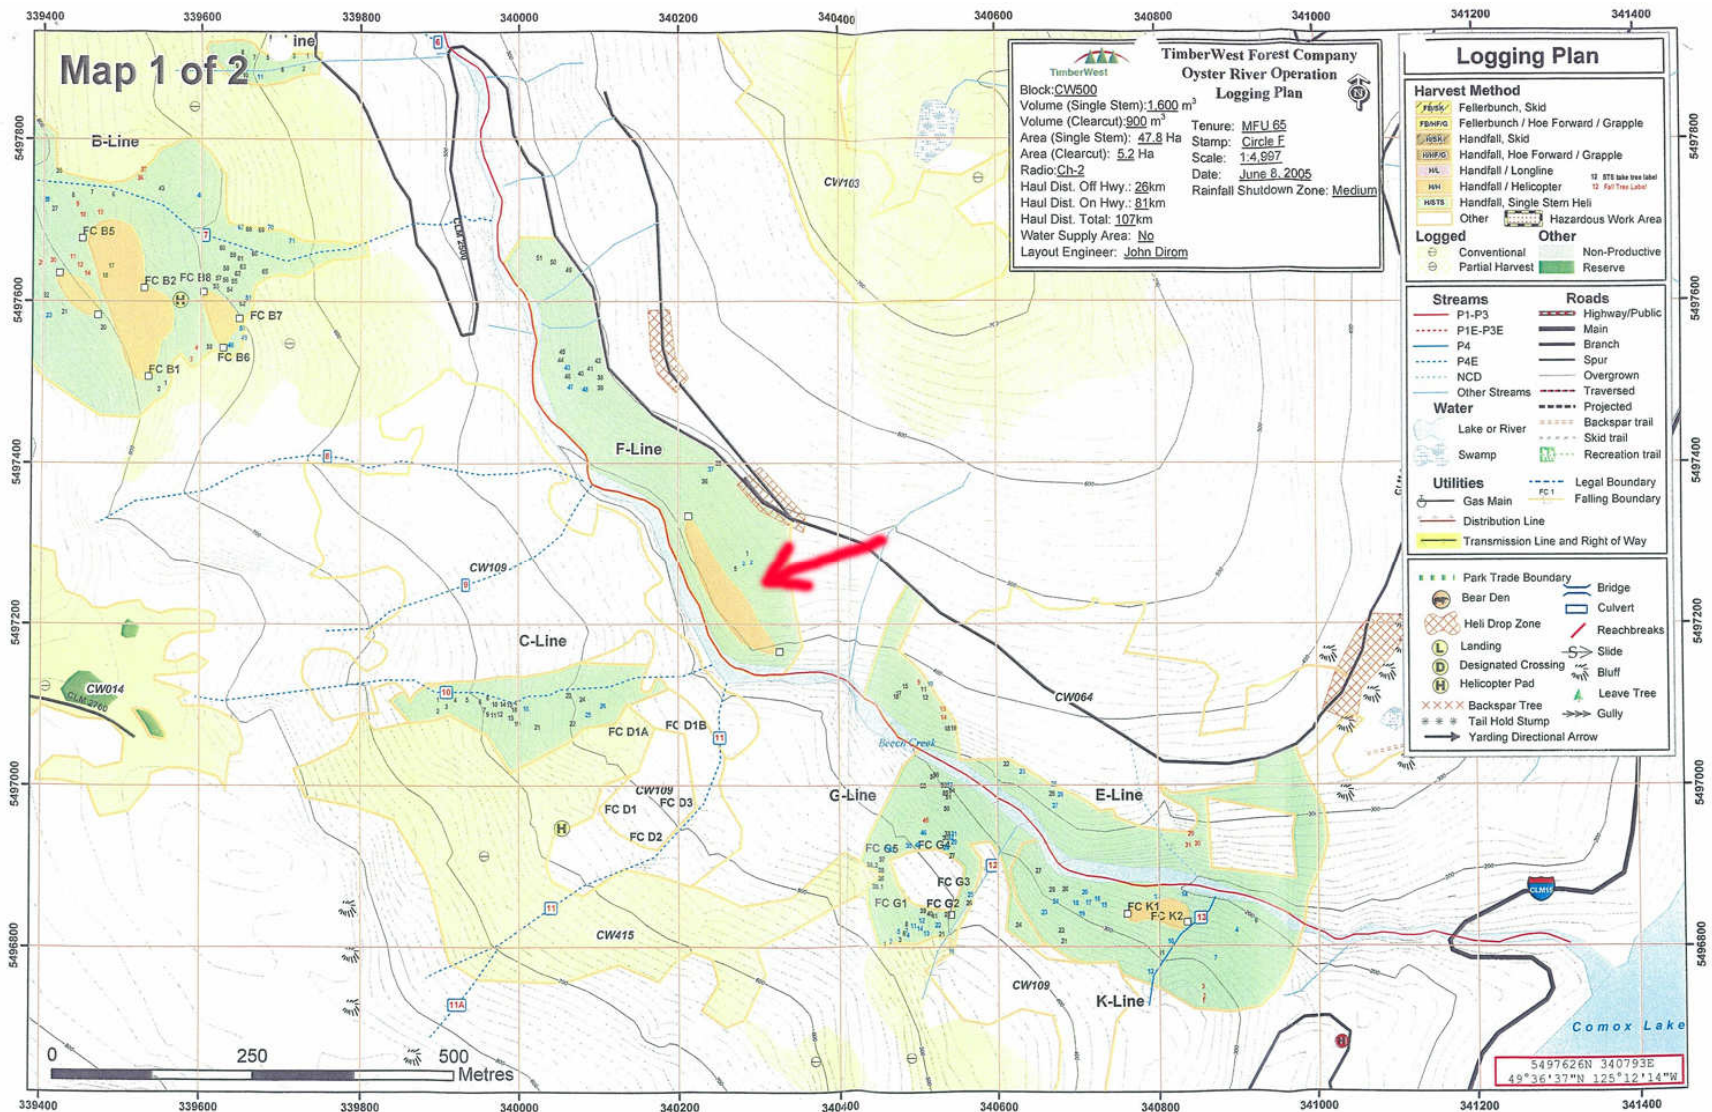
The Block is located on a south-facing slope on the north side of Comox Lake. The area of the Beech Creek watershed is 1,660 hectares and is located in Managed Forests 8 and 65 (TimberWest Site Review Summary dated June 8, 2007). The clearcut area of the Block is 5.2 ha and harvesting occurred during 2005 (Figure 1).

Figure 1 CW500 Block Map. The red arrow points to the area of interest.
