CK106 Block Assessment Kweishun Creek

- TimberWest Forest Corp. -

Block Assessment of CK106 Kweishun Creek TimberWest Forest Corp.

November, 2007

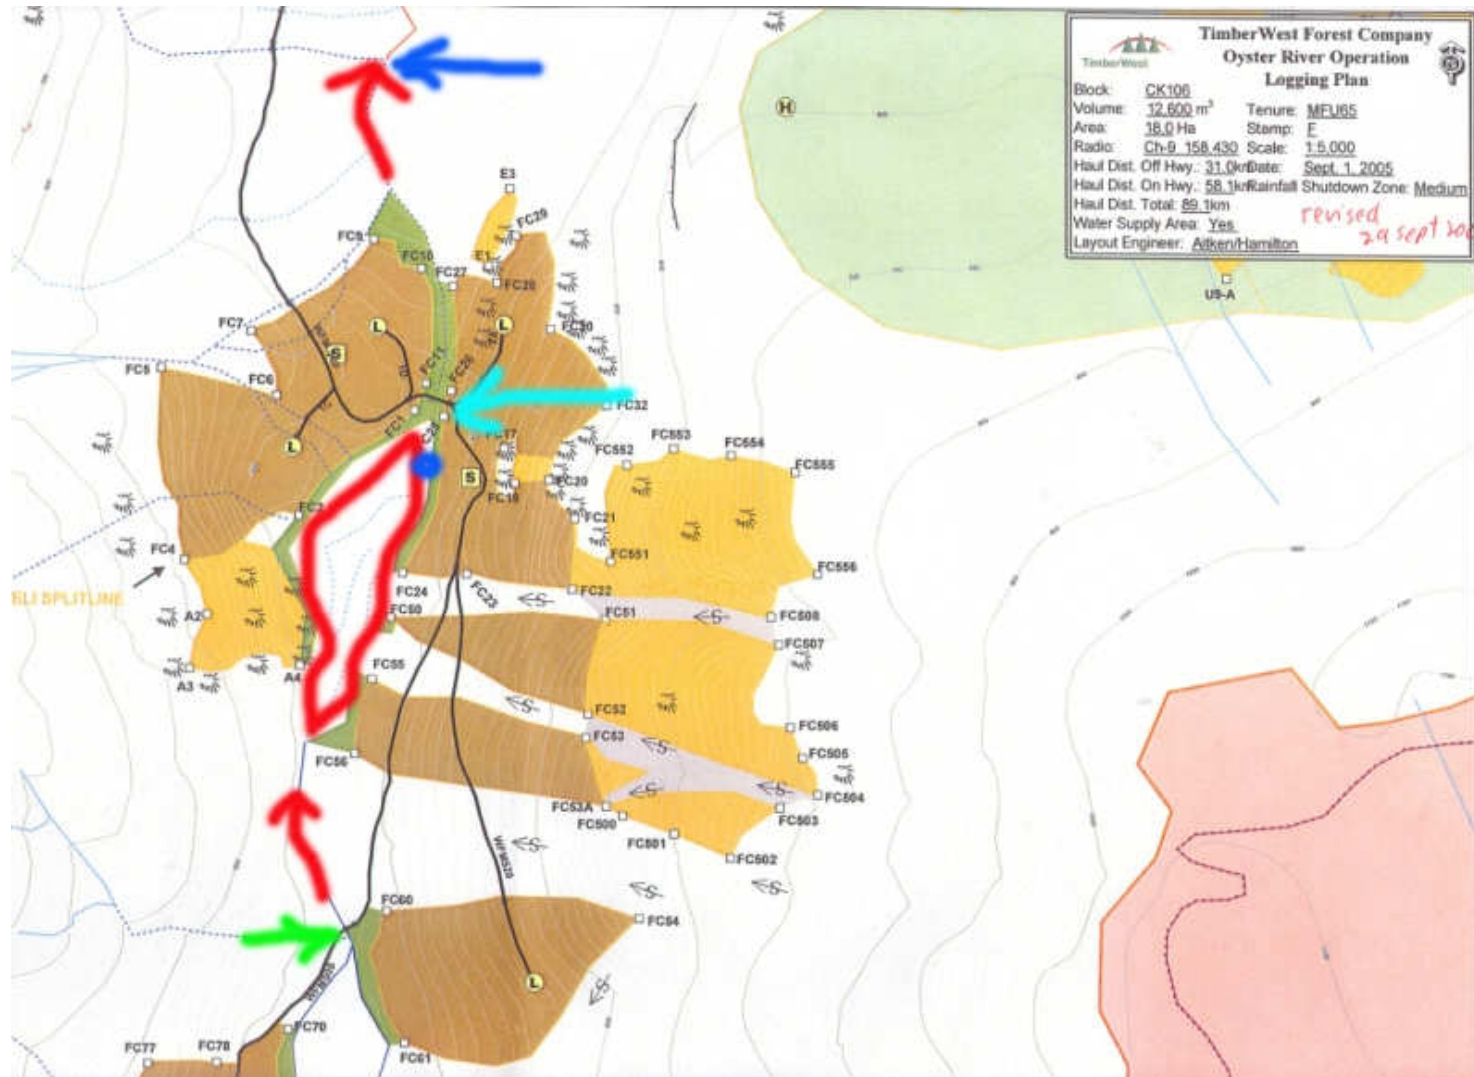
The Block is located in a narrow steep-sided valley on a reach of Kweishun Creek that flows in a northerly direction. The Block is in Managed Forest 65 and the Block area is 18 ha (Figure 1). Harvesting occurred during 2006. Kweishun Creek flows through the center of the Block and then flows in a north-easterly direction for about 1.6 km where it flows into Rees Creek. Rees Creek flows in an easterly direction for about 2.1 km to the Cruickshank River. The Cruickshank River flows directly into Comox Lake approximately 4.2 km (river distance) to the east.

Figure 1 CK106 Block Map. Red arrows indicate stream location and direction of flow. The meadow area is circled in red. Location of the upper stream crossing is indicated with a bright green arrow. The bright blue arrow shows the lower road crossing at the alluvial constriction. The dark blue arrow is at the approximate location of the upstream limit of fish use and the dark blue dot shows where the stream goes sub-surface in the meadow.
